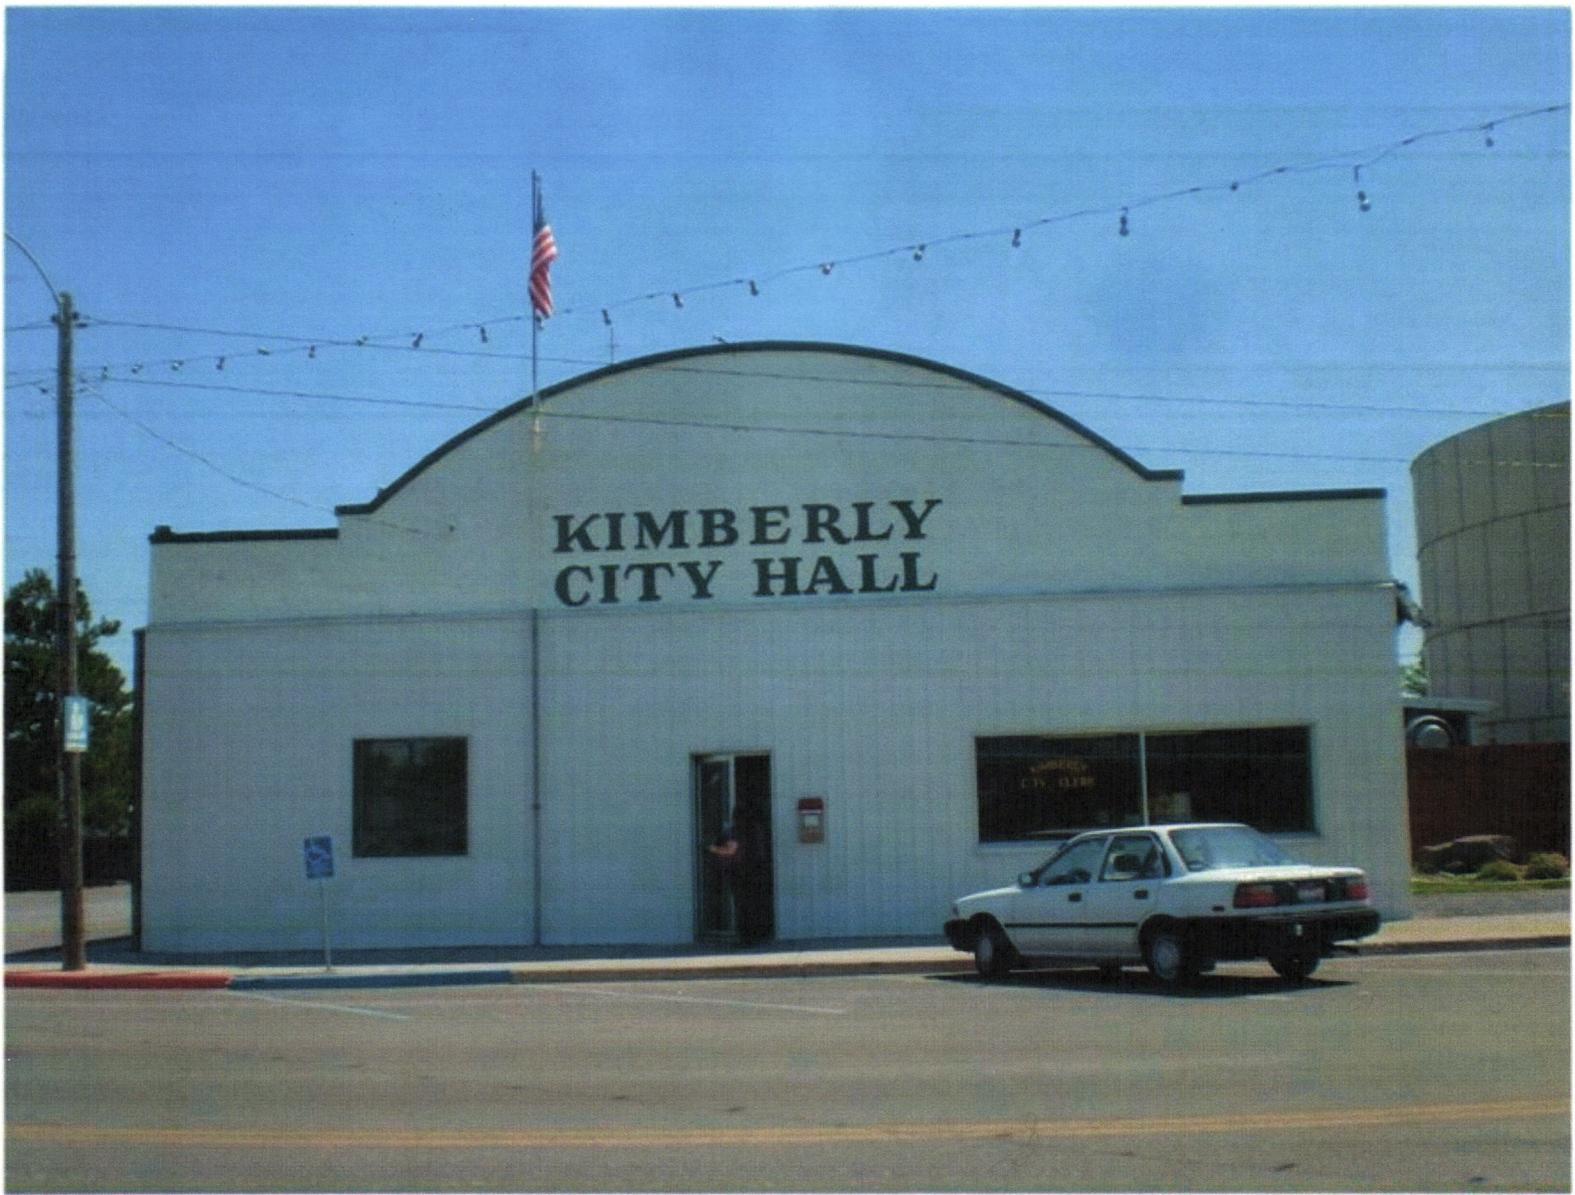
The front of the building with the facade. Facades are known weak areas in older building that tend to fall. This one is supported by the roof structure but it is unknown to what extent that support actually is.

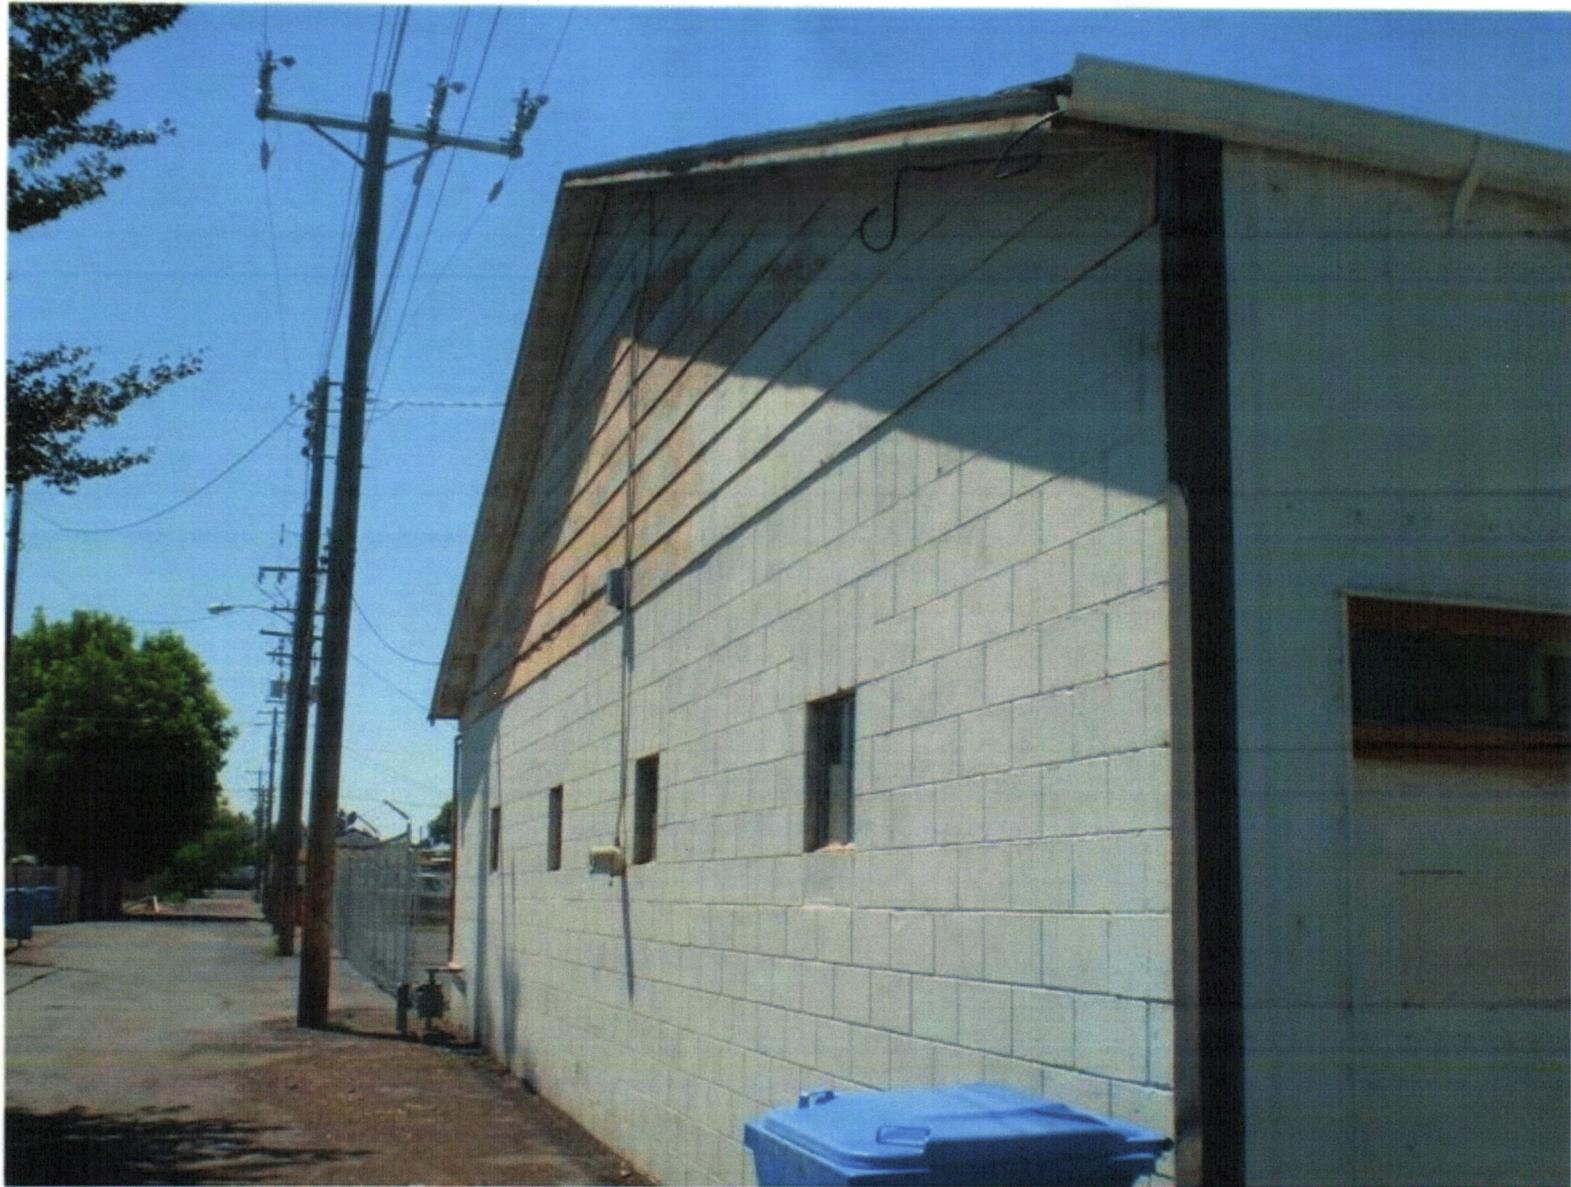
This is the east end of the building. This end is an addition that is newer construction.

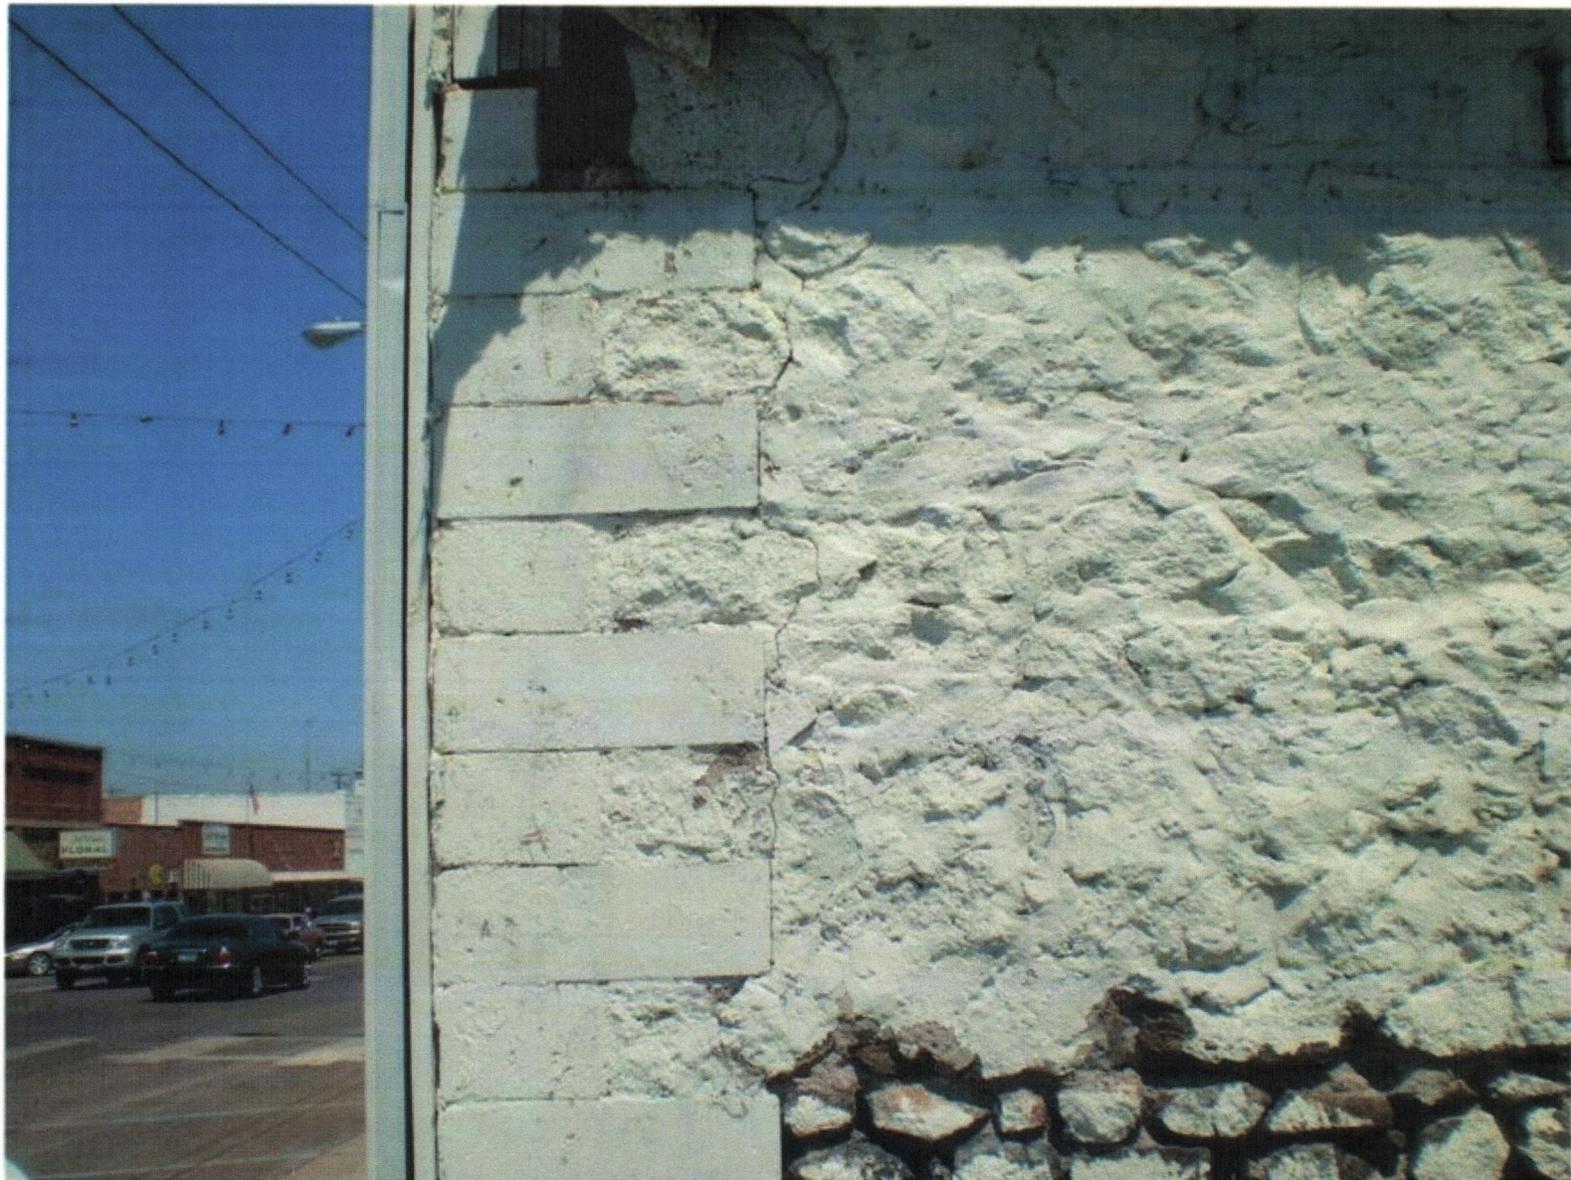
This is the crack at the southwest corner. The flat sided masonry was installed to lock the corner in place and it has simply cracked at the end of the finger joints. This cracks appears to have been caused by expansion of the wall due to the hot days and cool night of our area.

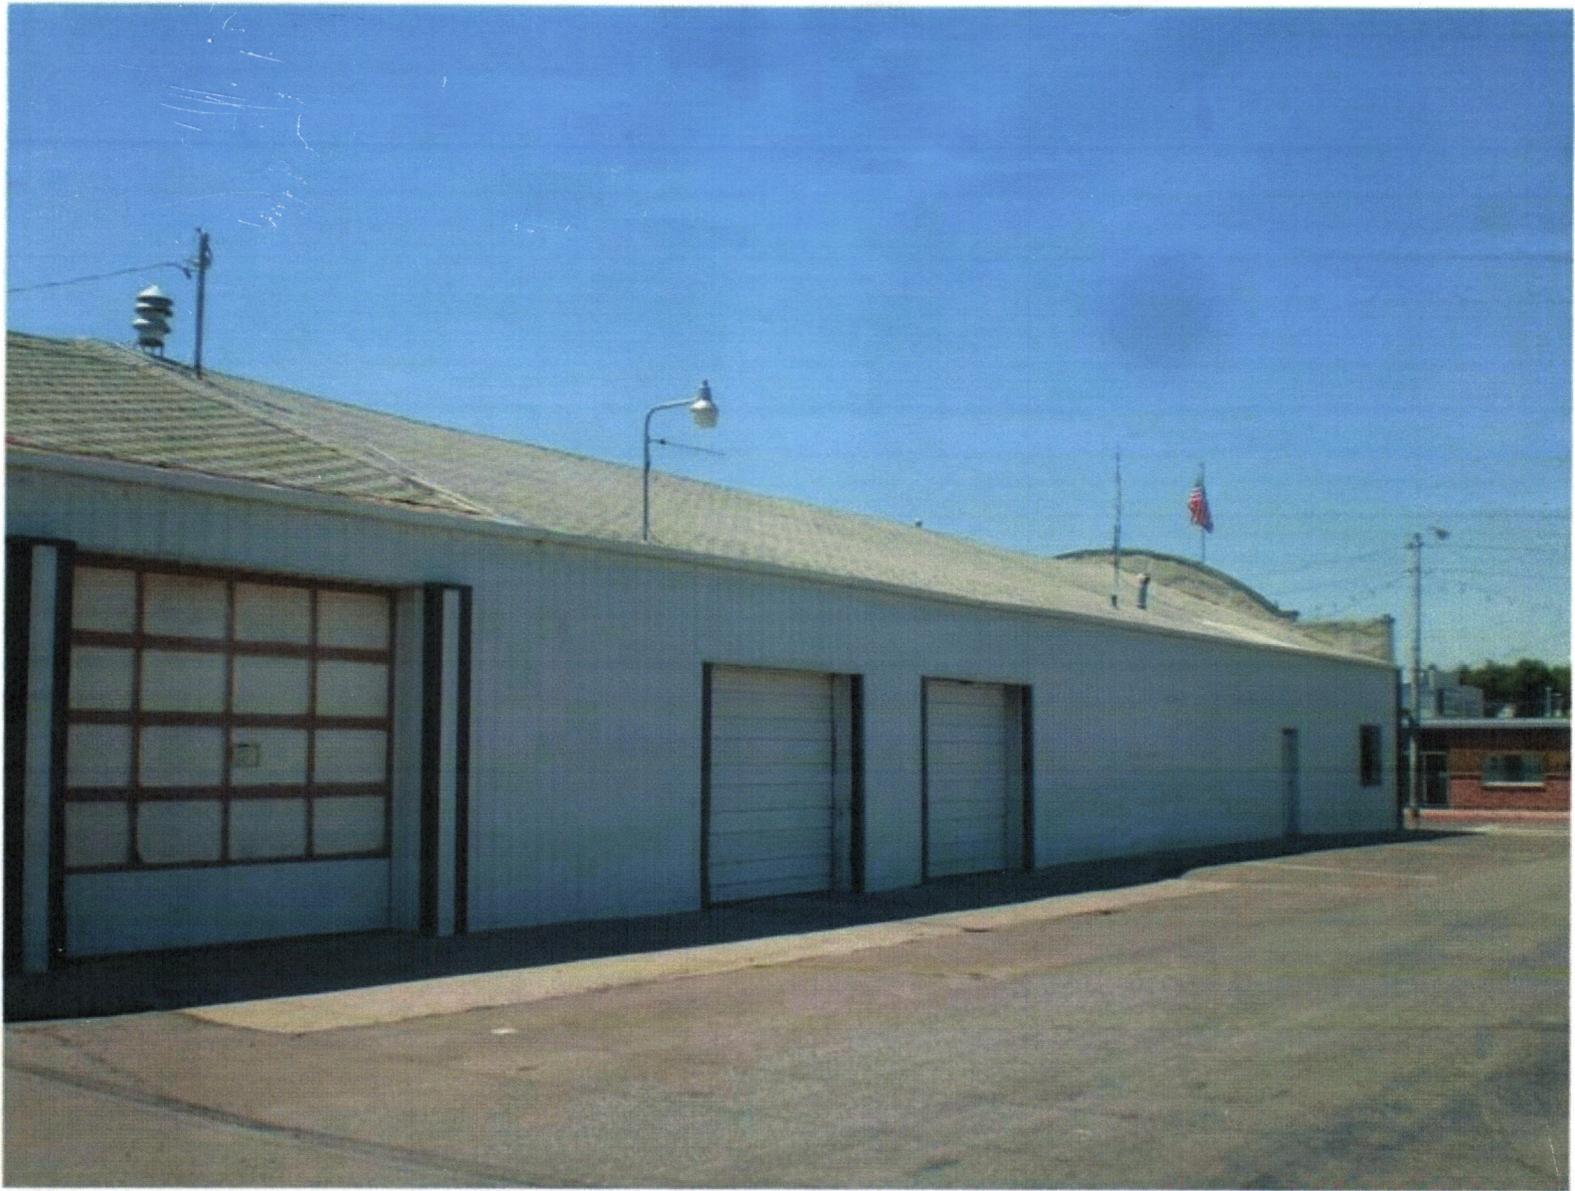
The north side of the building. The roof has sagging spots on both sides. The photo does not show the extent of the sagging but the eye sees them readily.

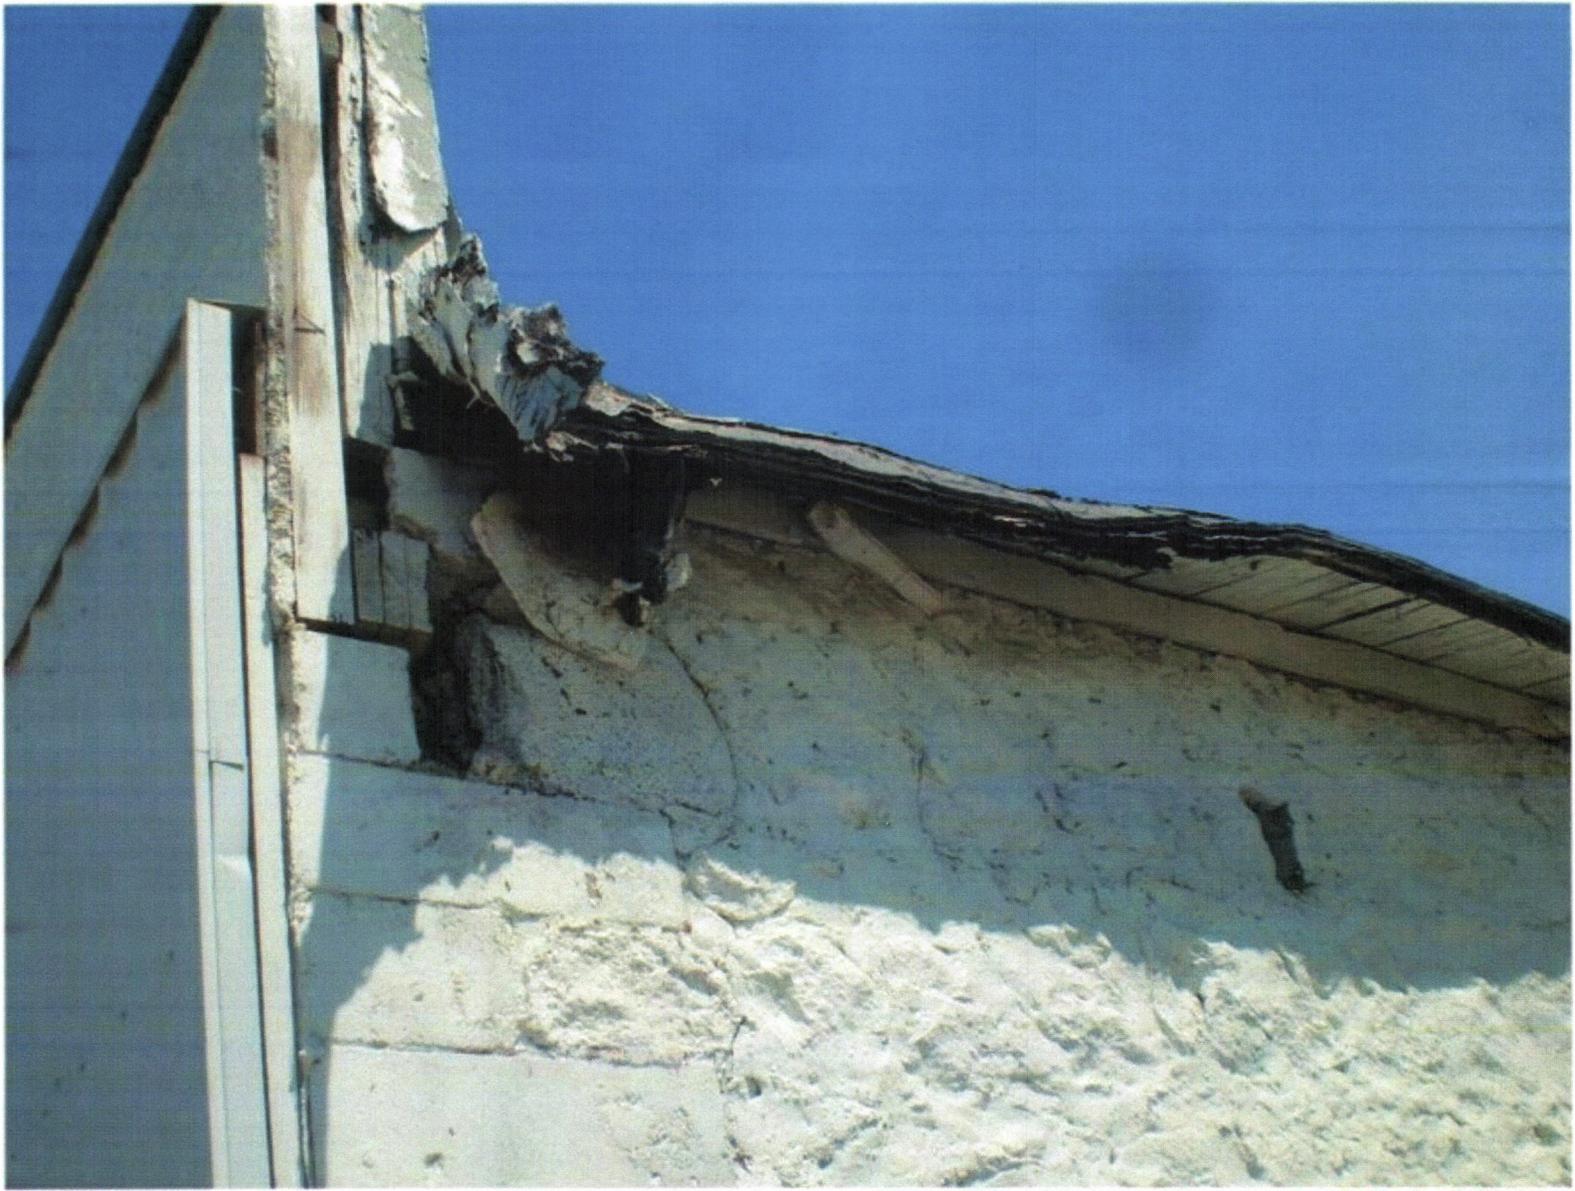
This is on the southwest corner. Roof sheathing failure was likely caused by wind driven moisture. The number of shingle layers on this roof far exceeds the amount allowed by code (Current code only allows two layers). The concern is weight on the roof structure and fuel load in case of fire. There is missing masonry and exposed wood and the wall is not weather tight. Any openings allow moisture entry which deteriorates building materials, Mold is often a result of moisture entry.

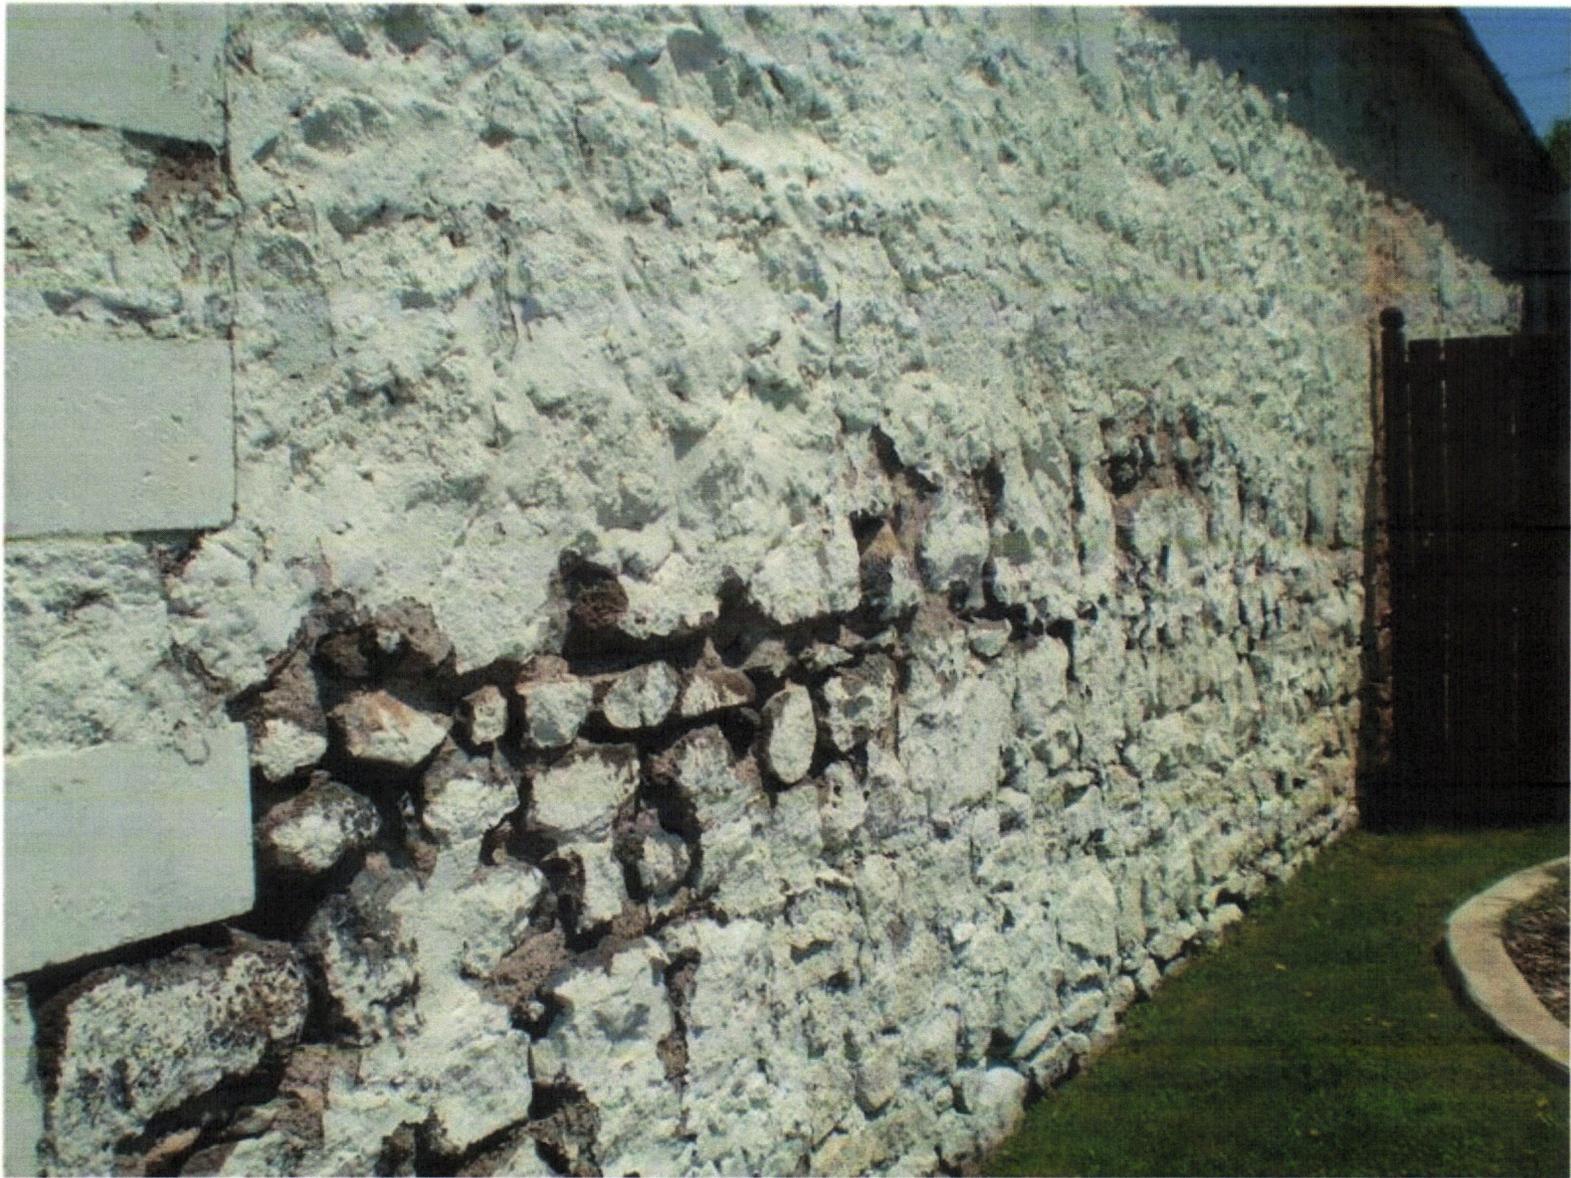
This is the front of the south wall. The deteriorated mortar is the result of moisture passing through the wall. The moisture is generated in the building or from beneath it and this is one of the locations it is exiting (evaporation) the structure.
