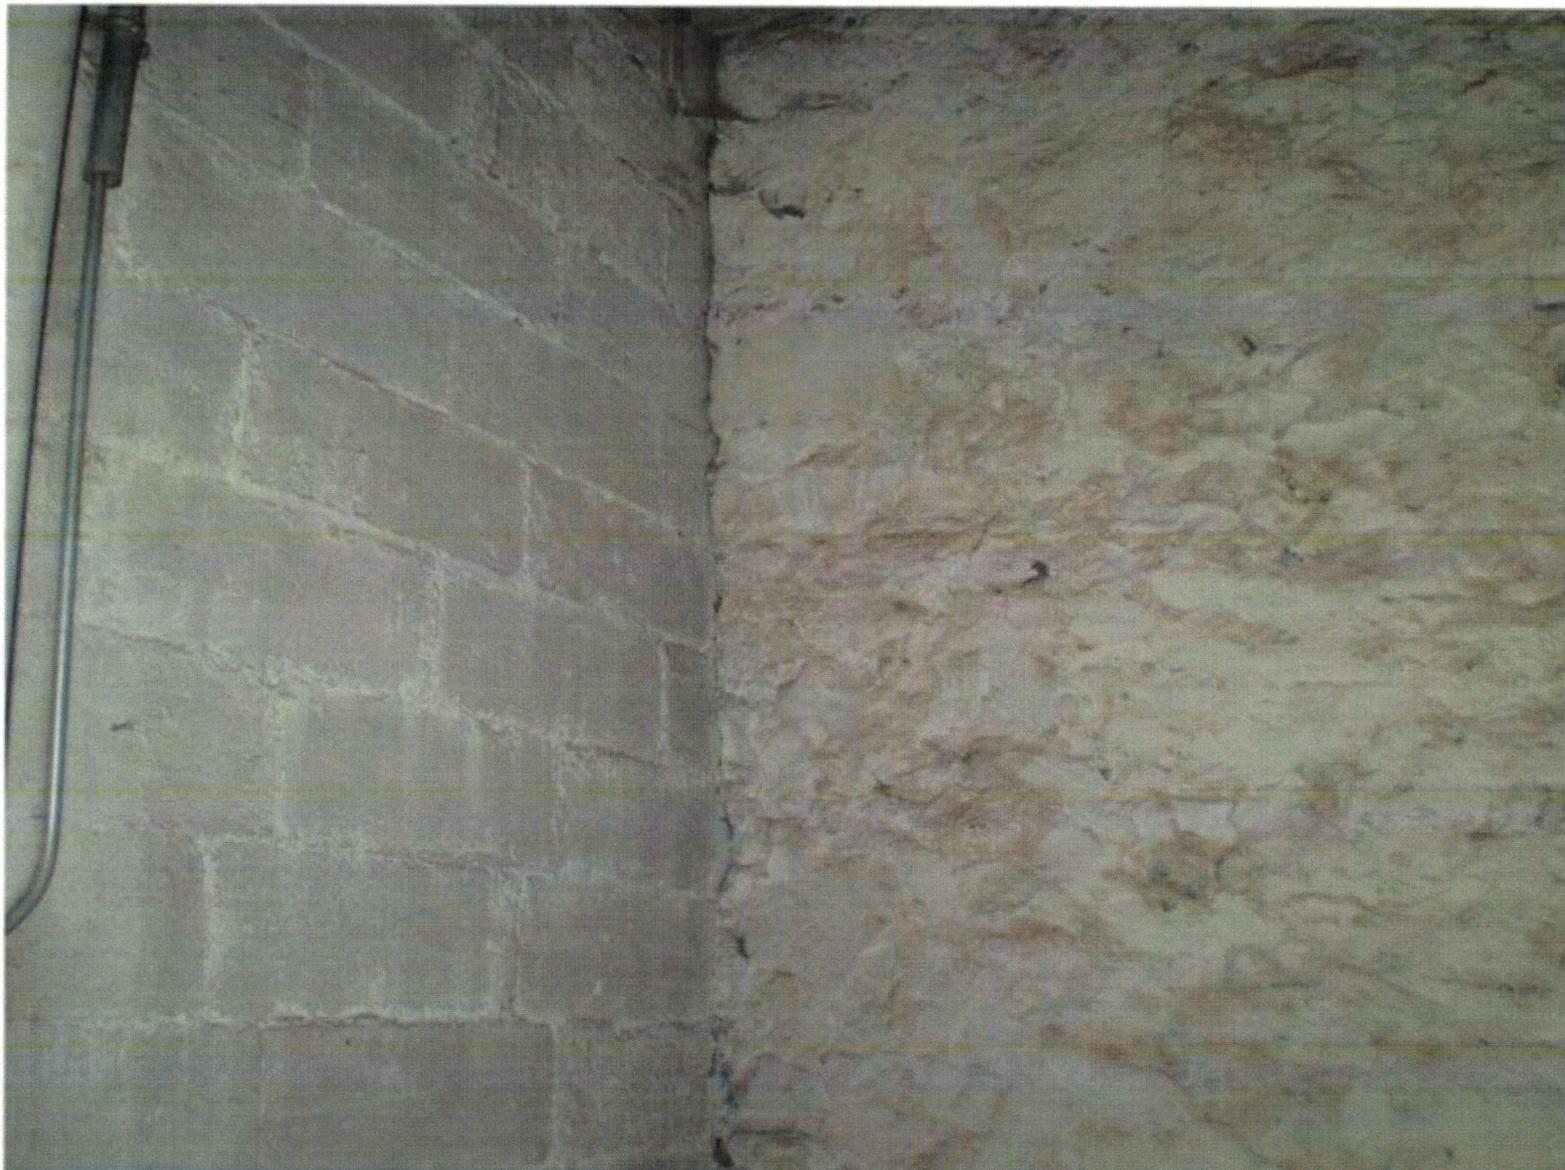
There is no way to tell by a cursory inspection if these two walls are tied together as would be required in modern construction methods.

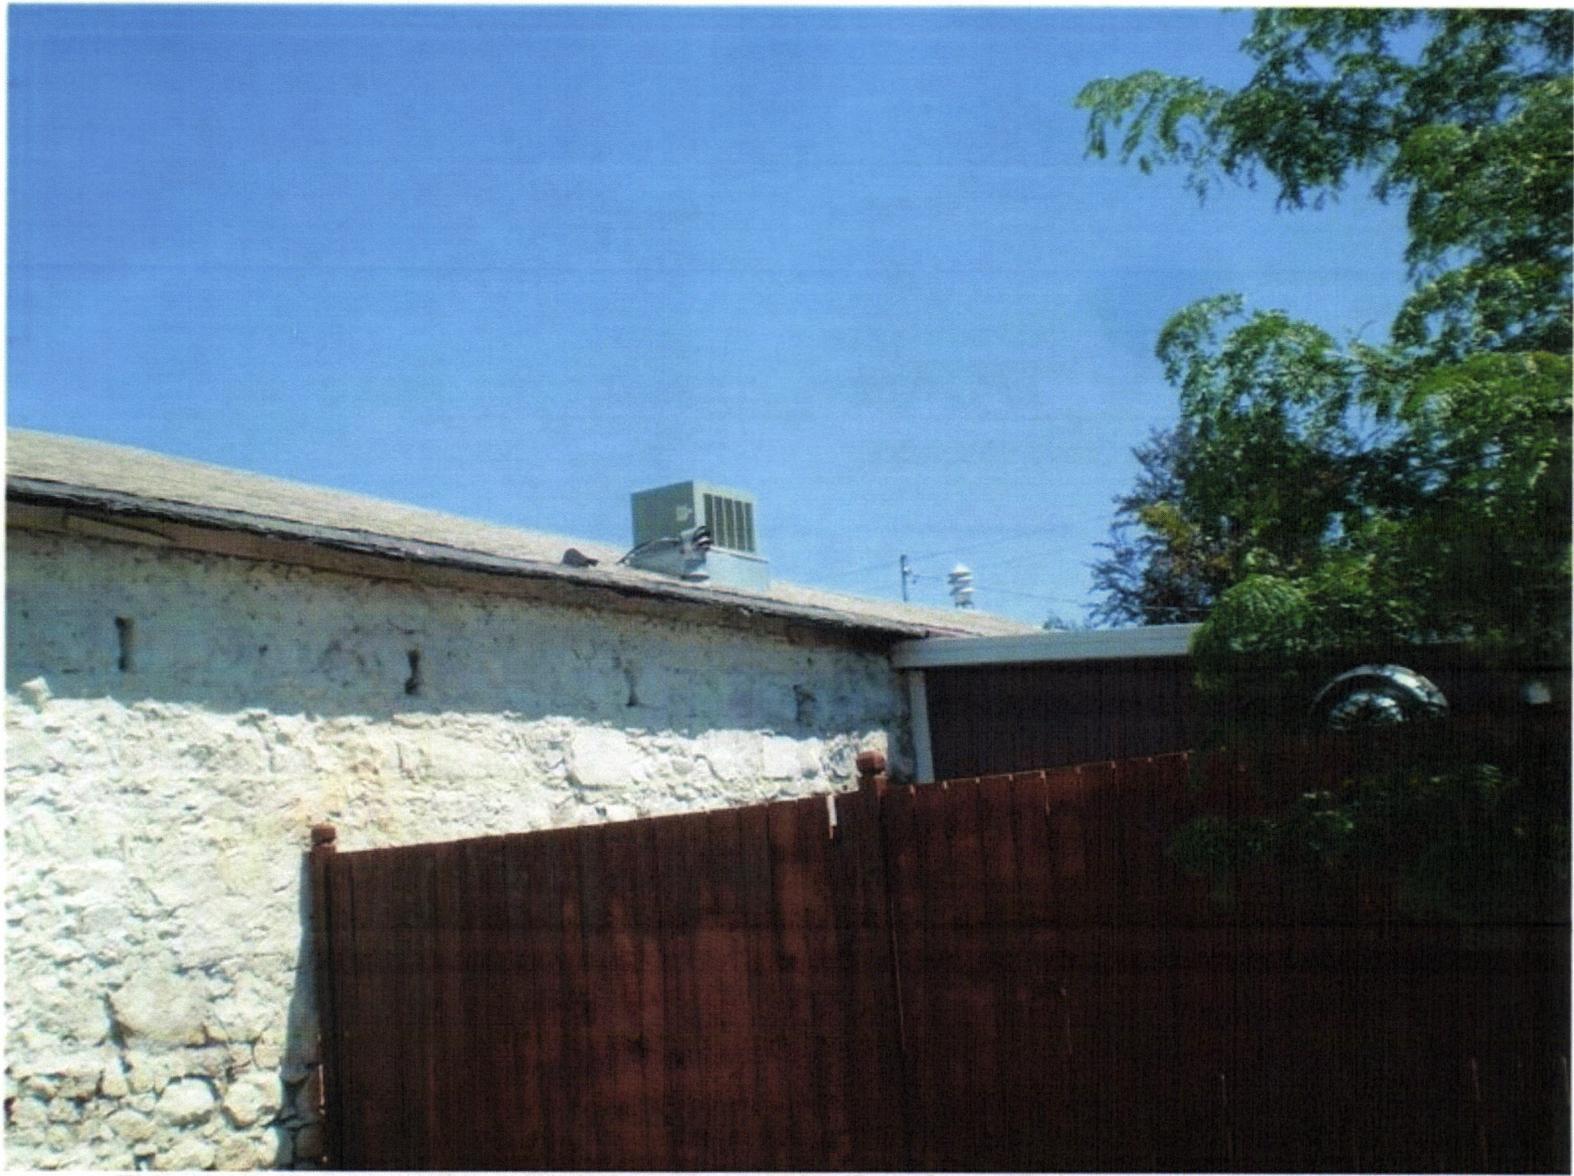
This photo is another attempt to show the sagging in the roof. This is the south facing slope.

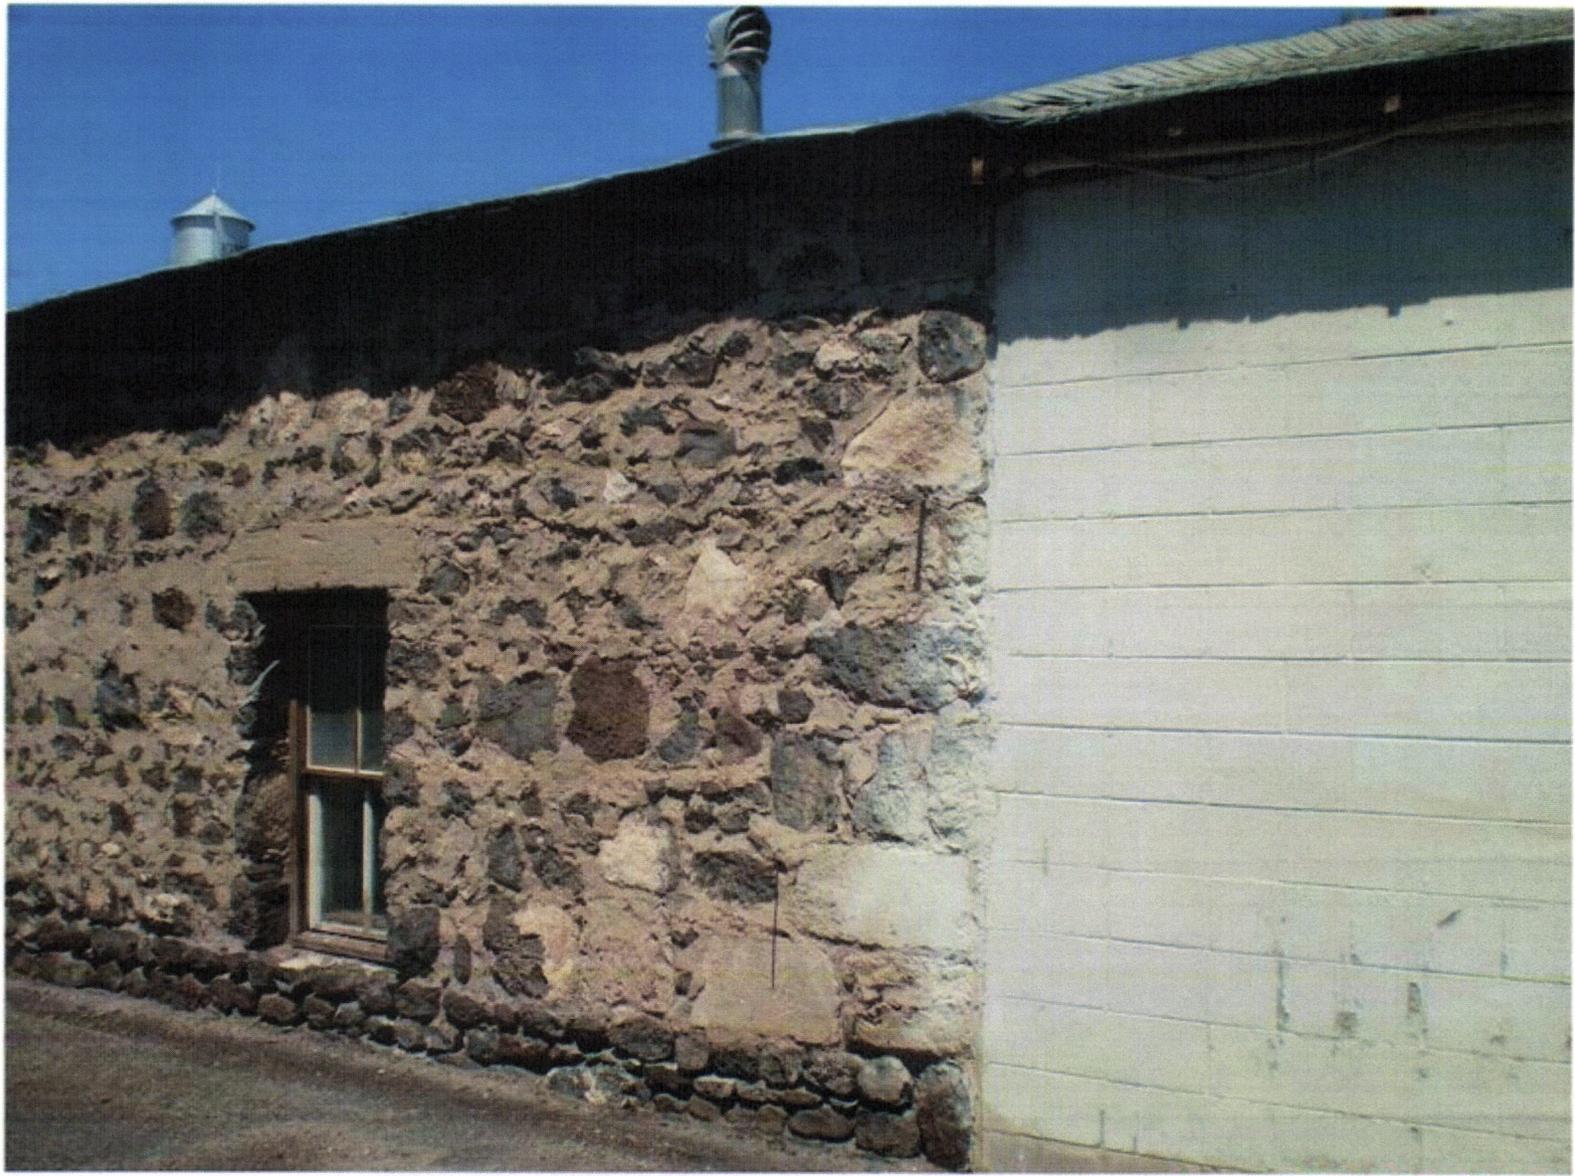
This is the old and new construction at its most obvious **Aug 4, 2008 13:16**

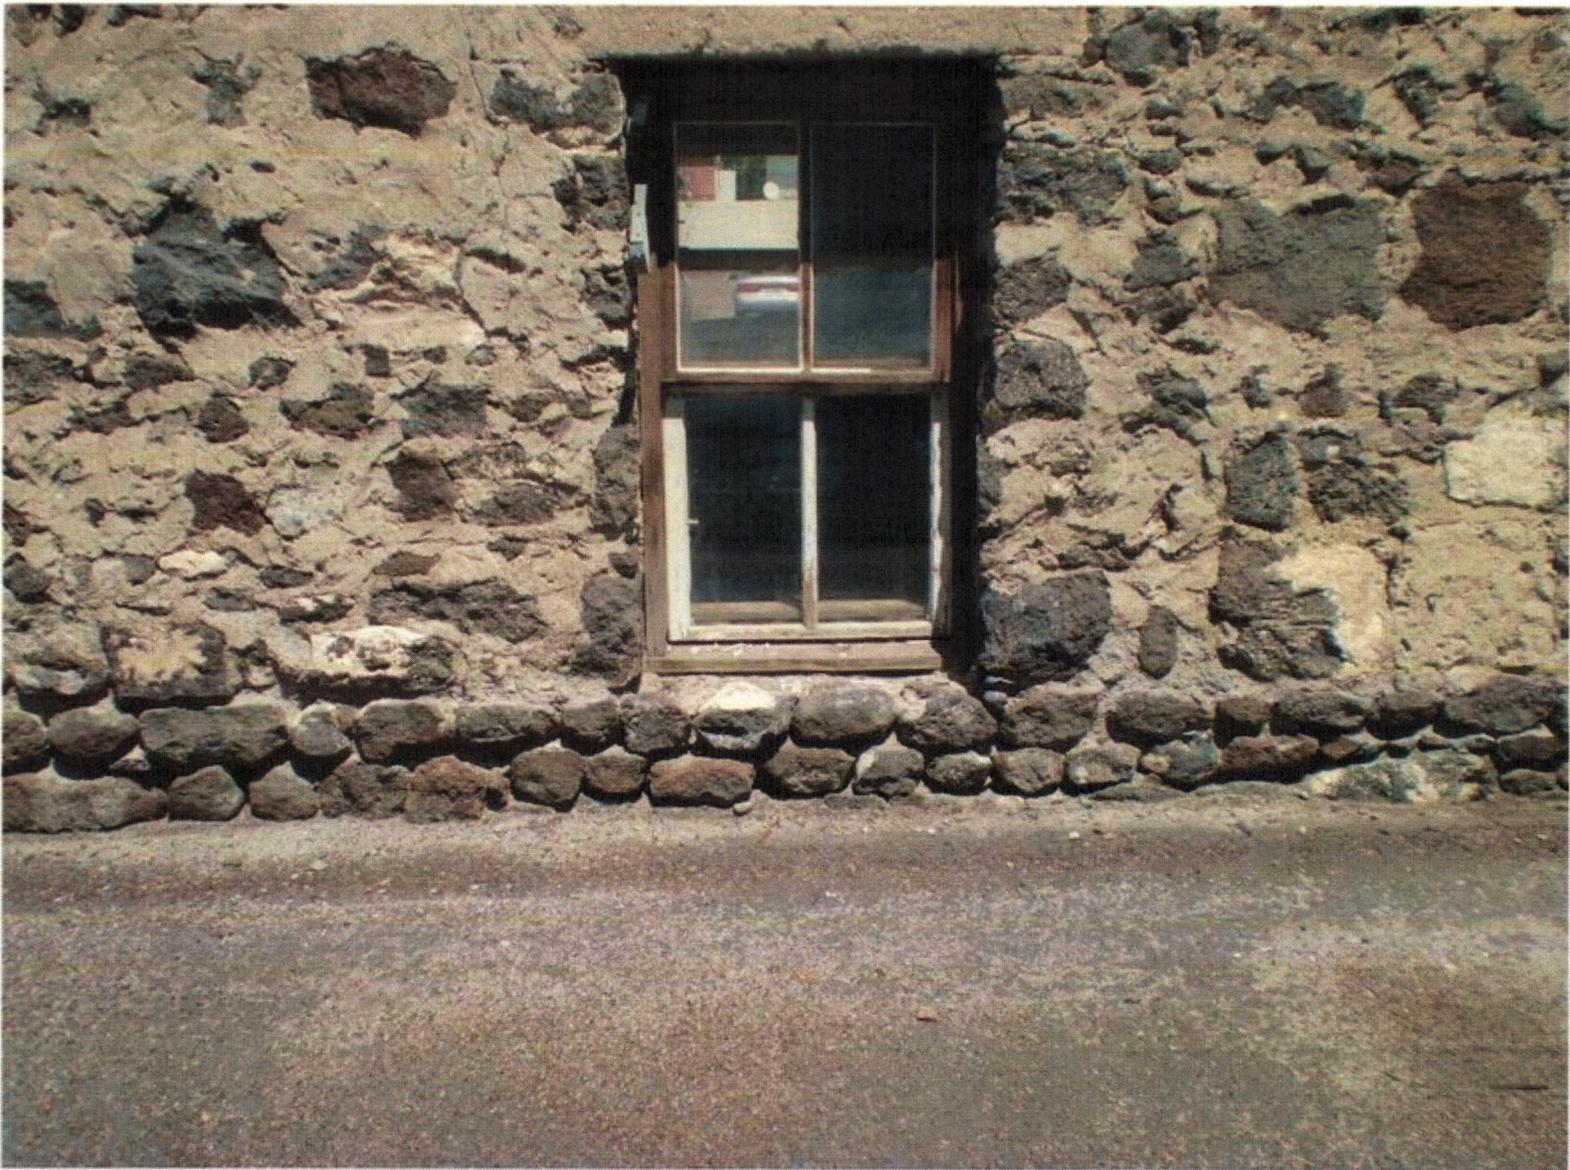
The bottom rows of stone show the loss of mortar. The style of placement is not conducive to strength.

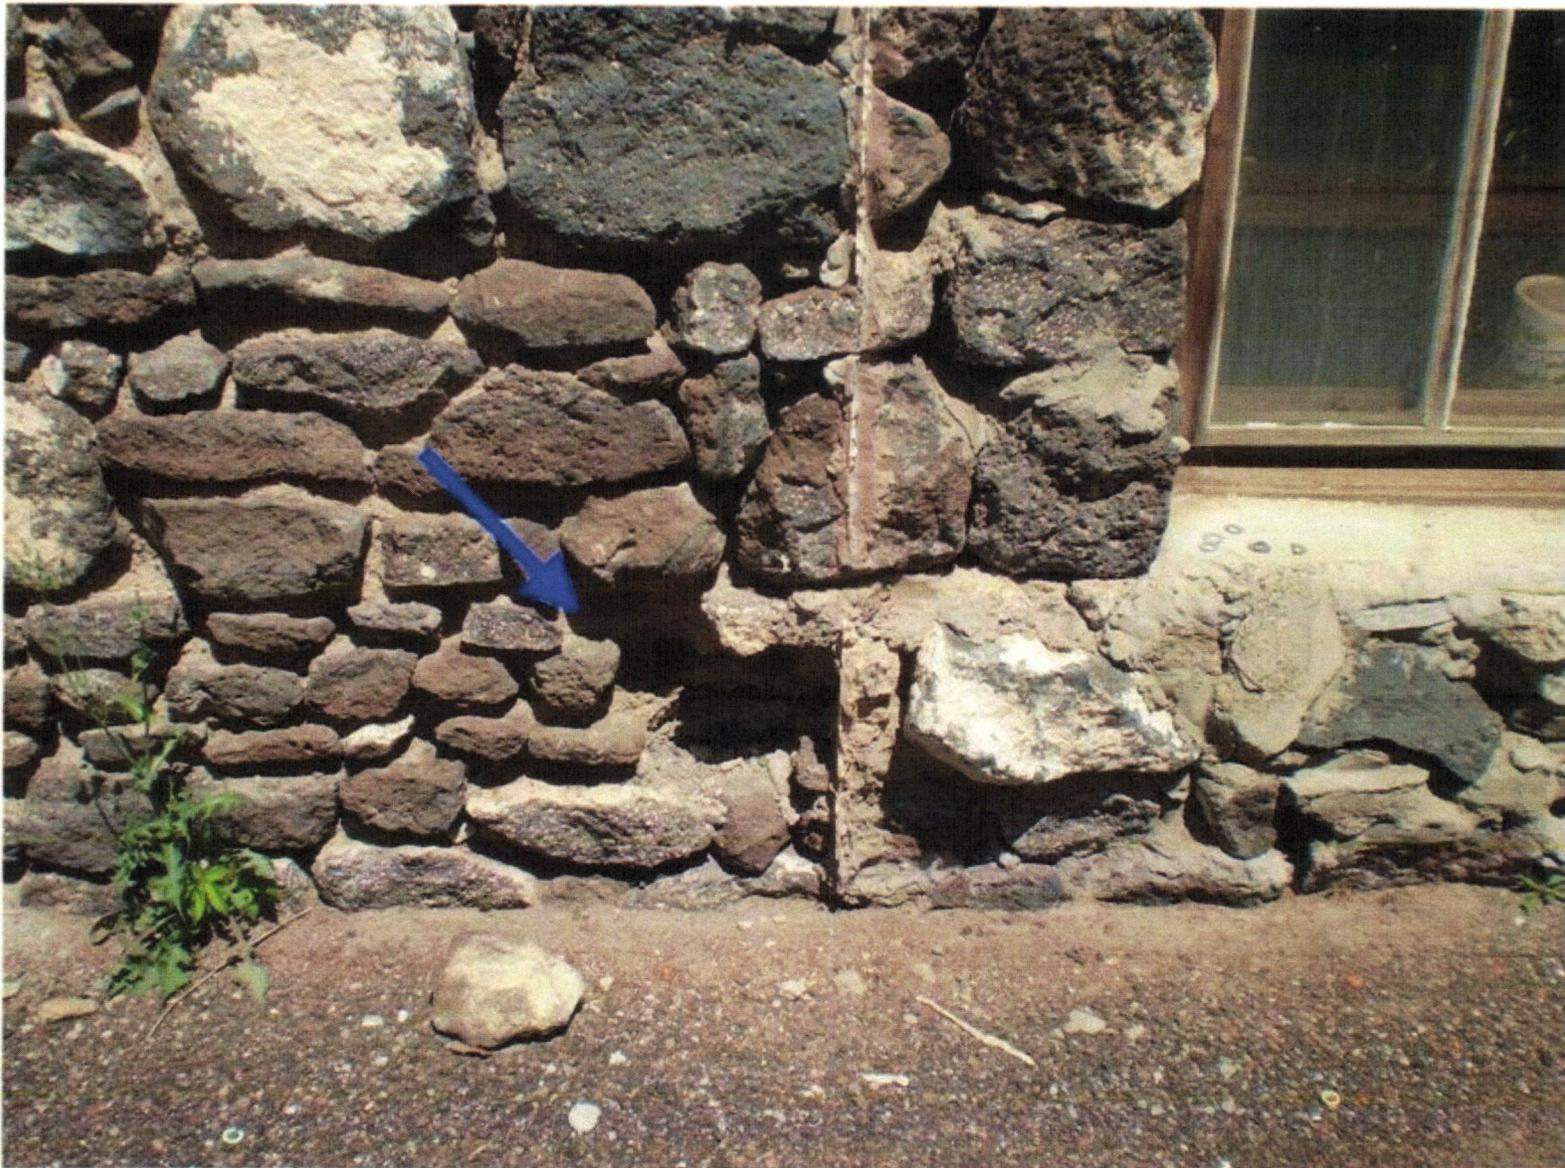
This view shows more missing mortar which equals a loss of strength. The arrow shows where a couple of stones have bone missing.

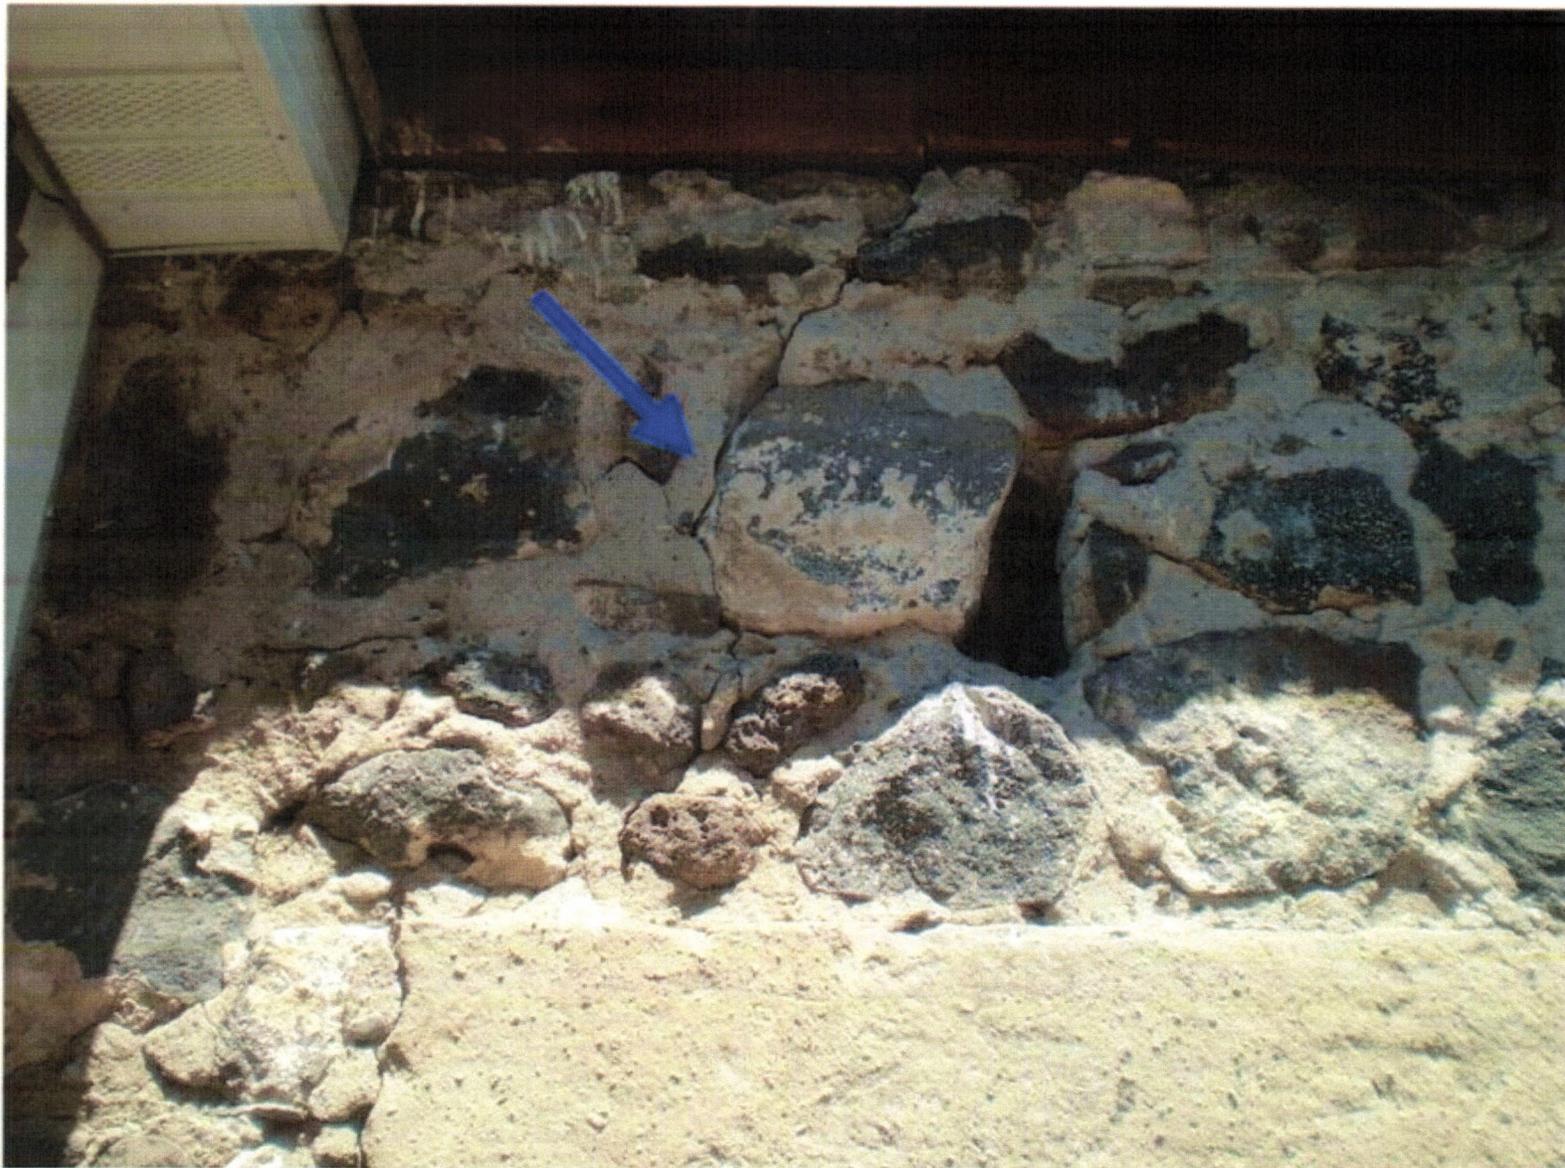
This is a step crack that is most likely due to the beam pocket.
