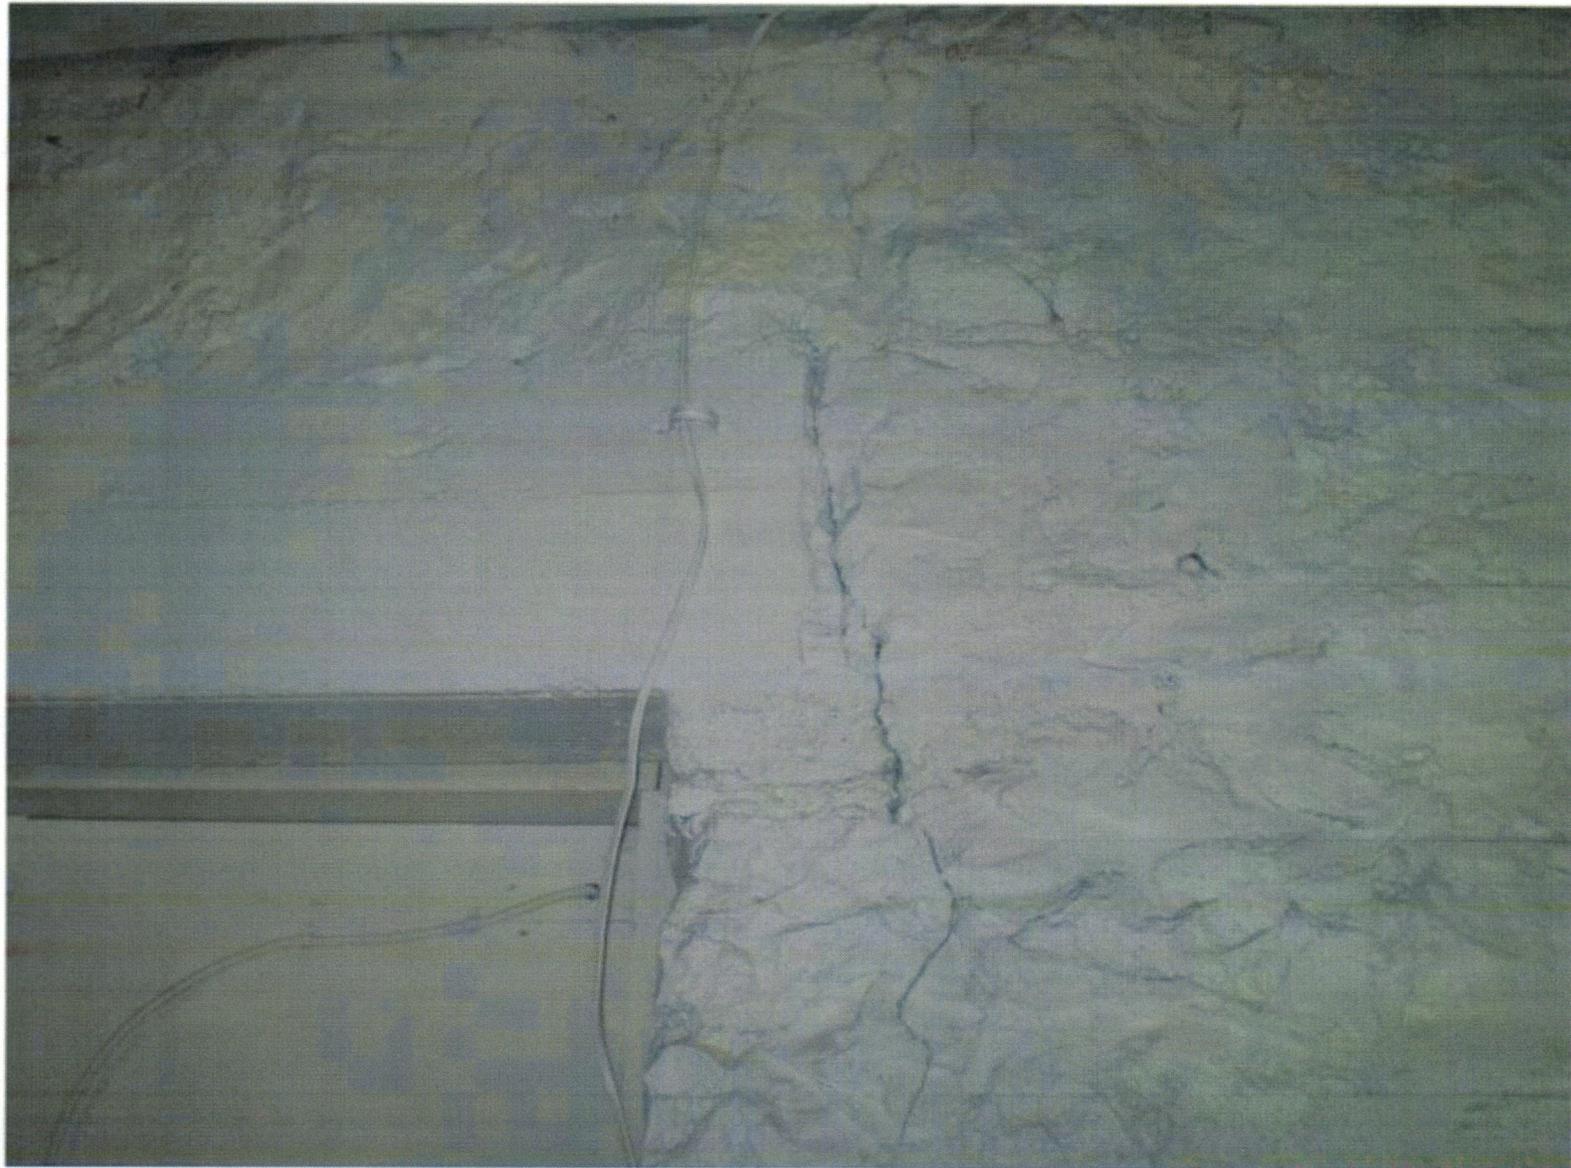
This is another interior crack.

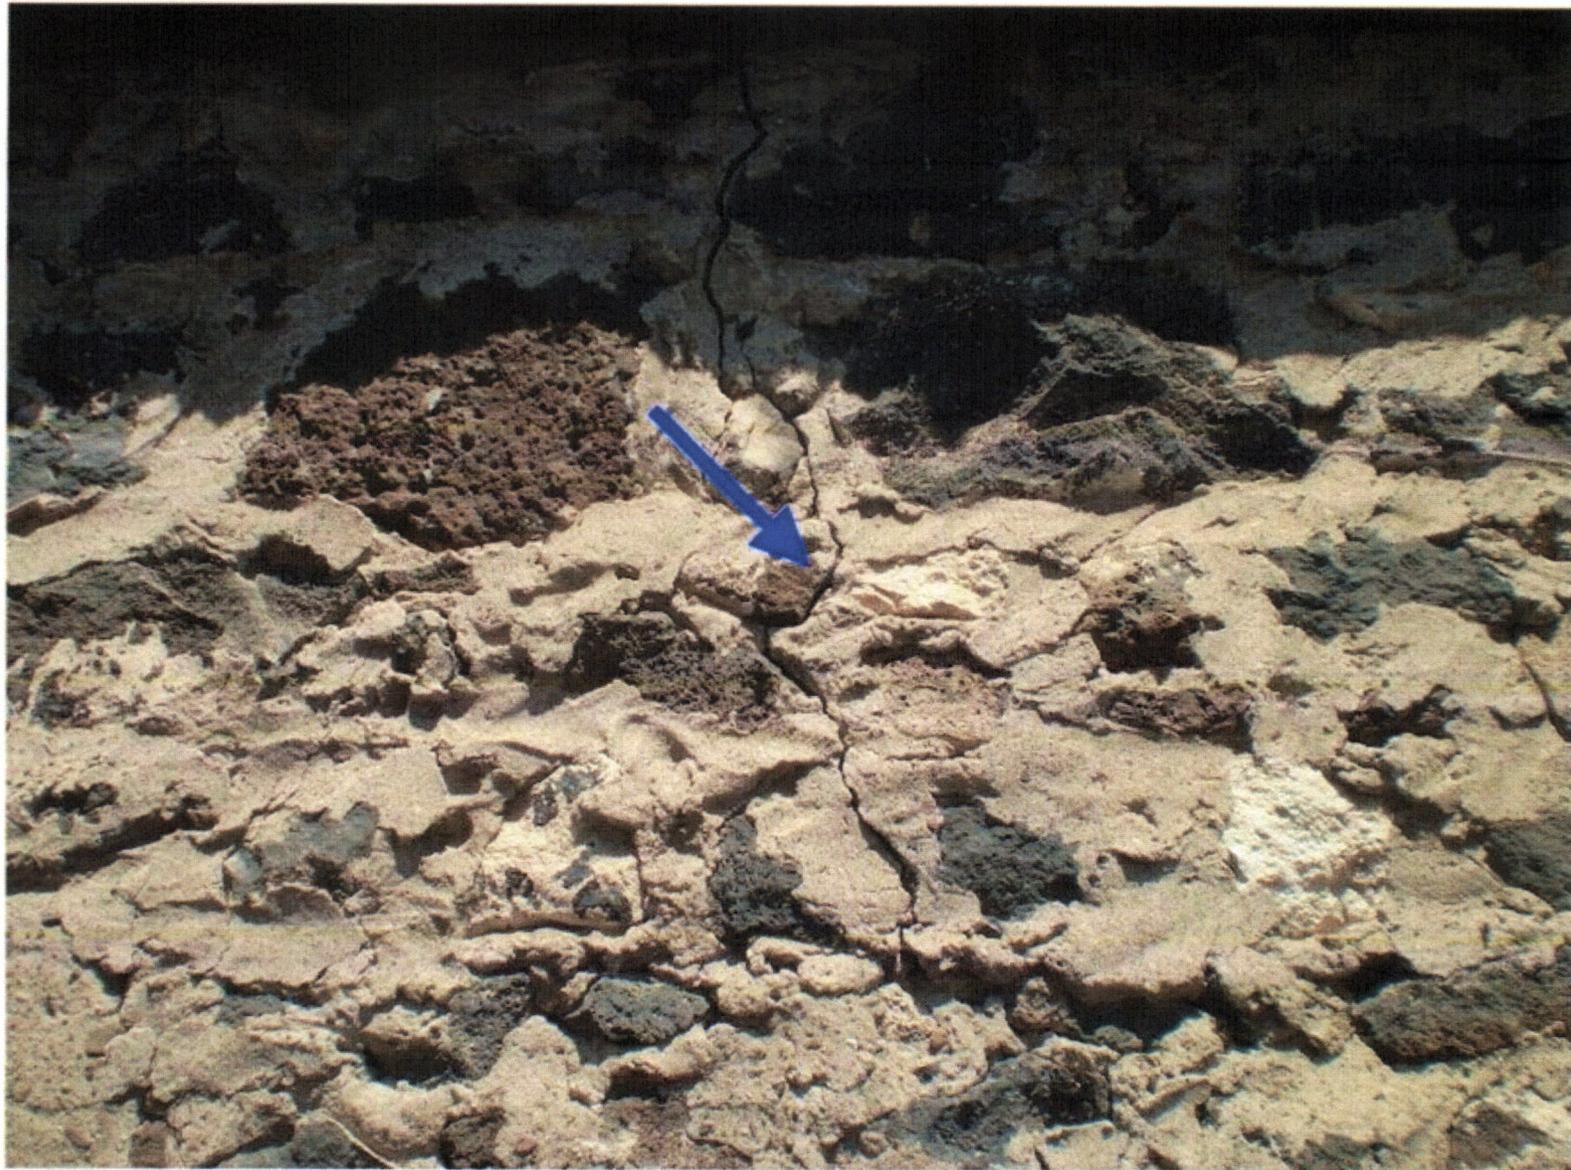
This crack is probably thermal related. The concern with these stone walls there is no rebar to hold the walls together when under stress such as settlement, impact or seismic activity.

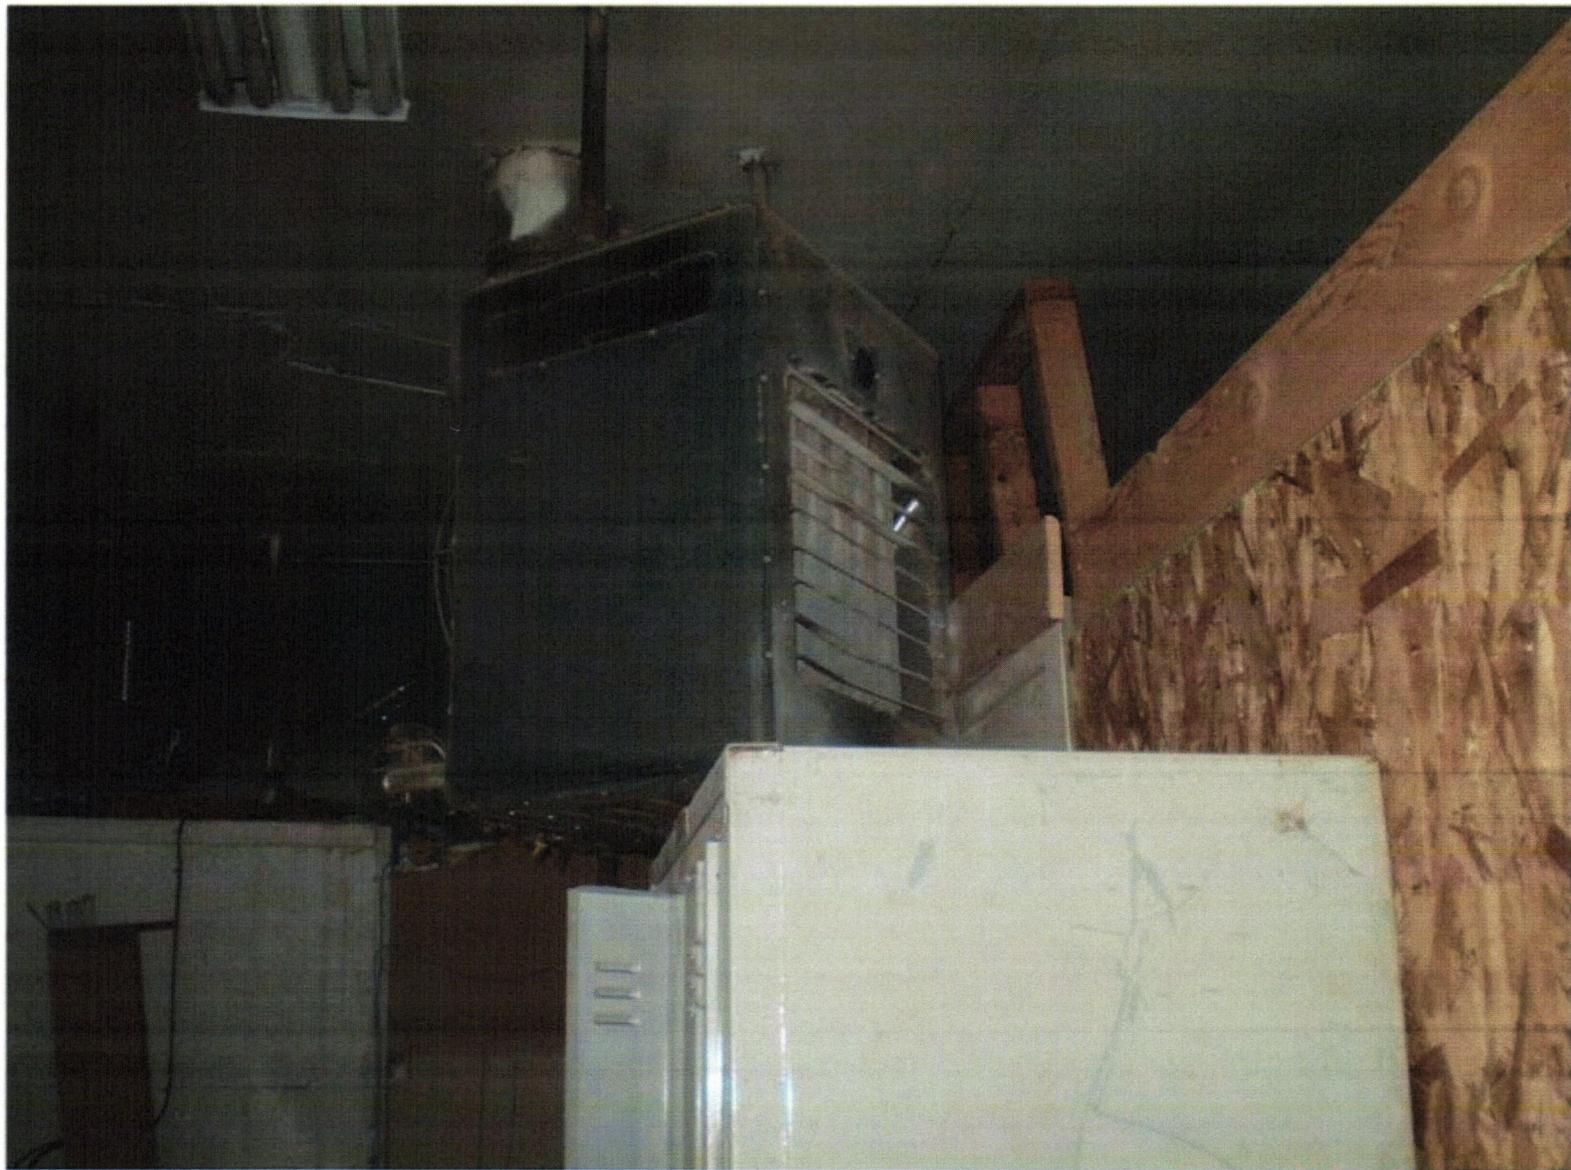
I was told this heater is not used which is good as its clearance to combustibles is not adequate.

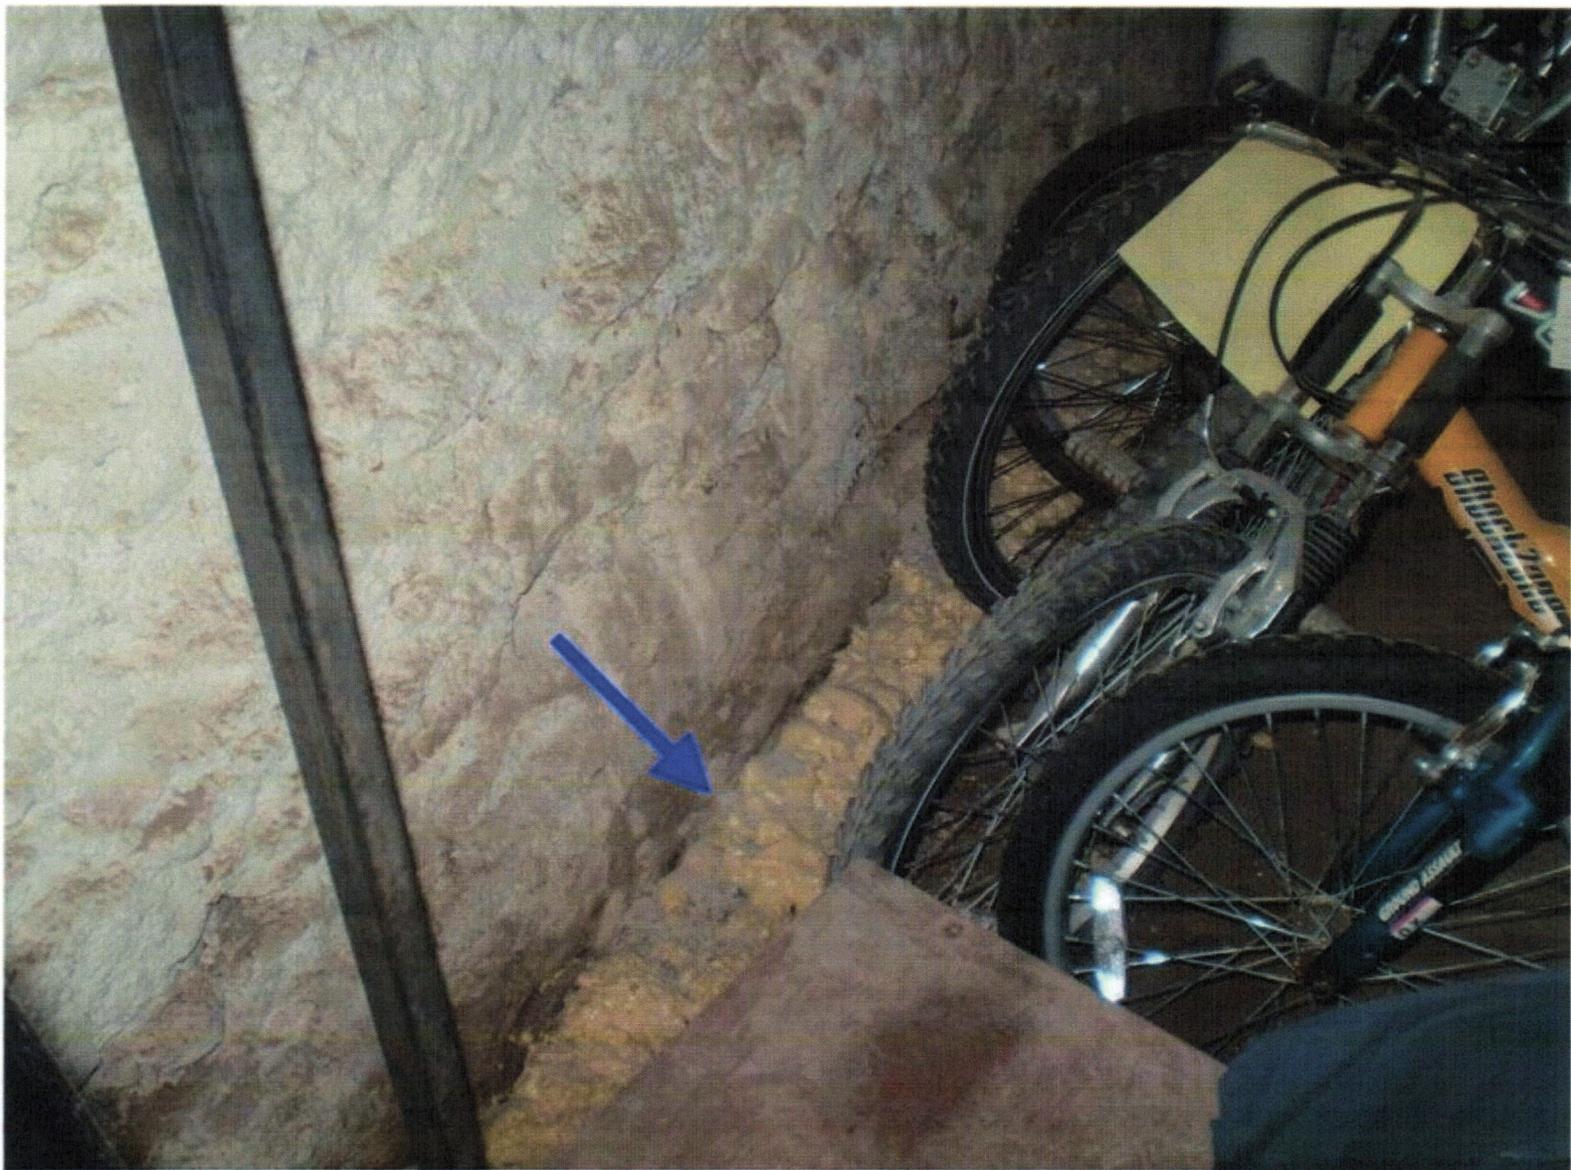
The arrow shows expanding foam that has been used to plug air infiltration. Aug 4, 2008 13:23

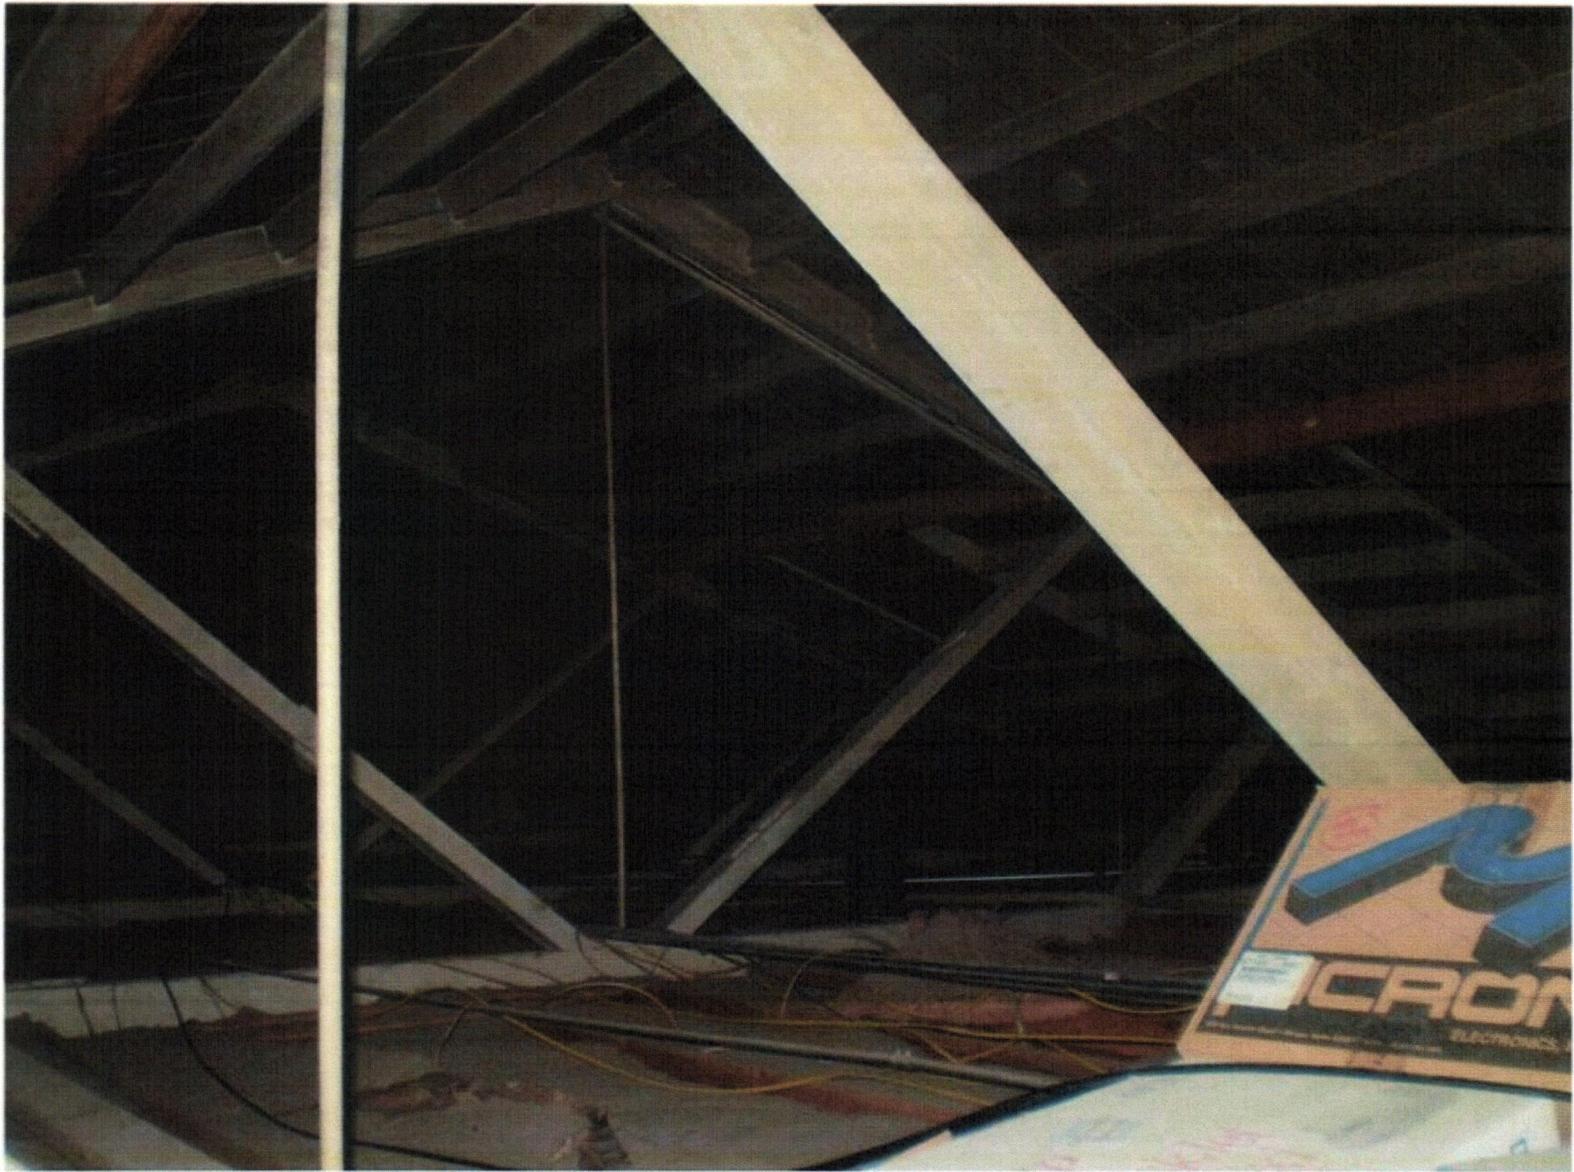
This is a general view of the attic. The light colored trusses are spaced about 12 feet and the original purlins (boards between) were originally 2X6's. The sagging of the roof indicates to me that the sagging includes some of the trusses being lower than others.

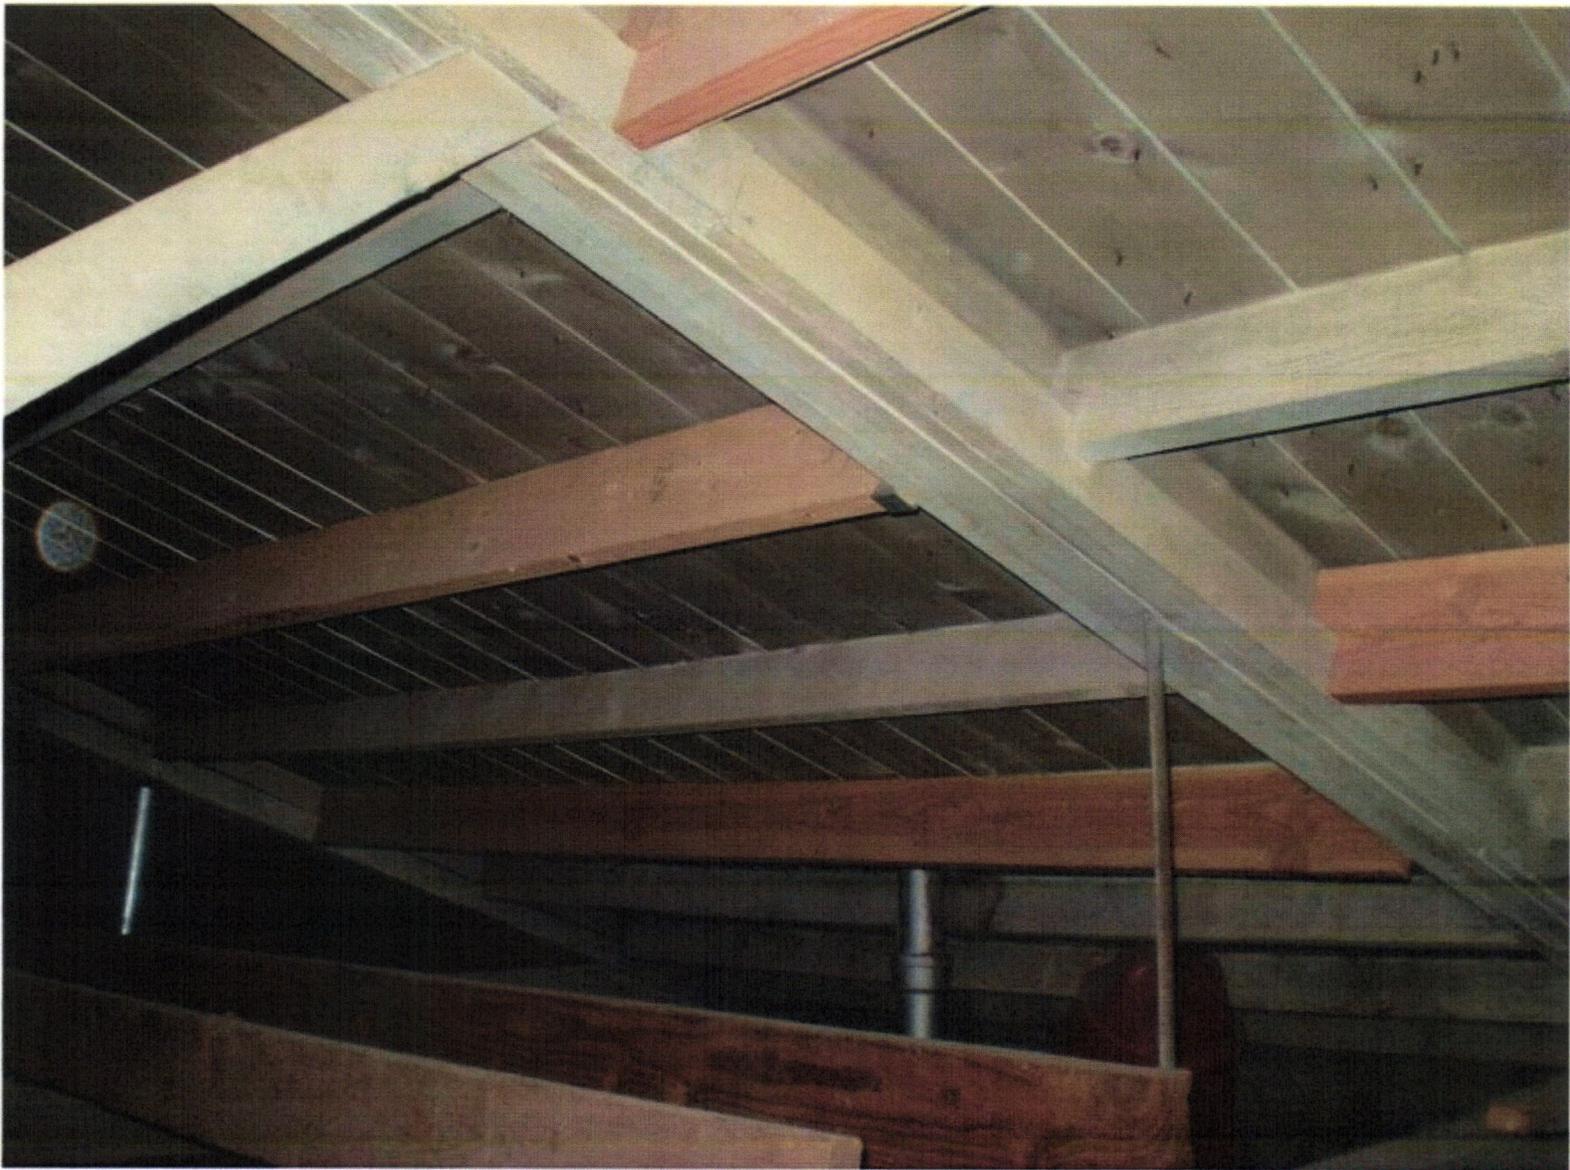
There has been repairs to the roof by sistering 2X8 boards to the original 2X6 pulins.
