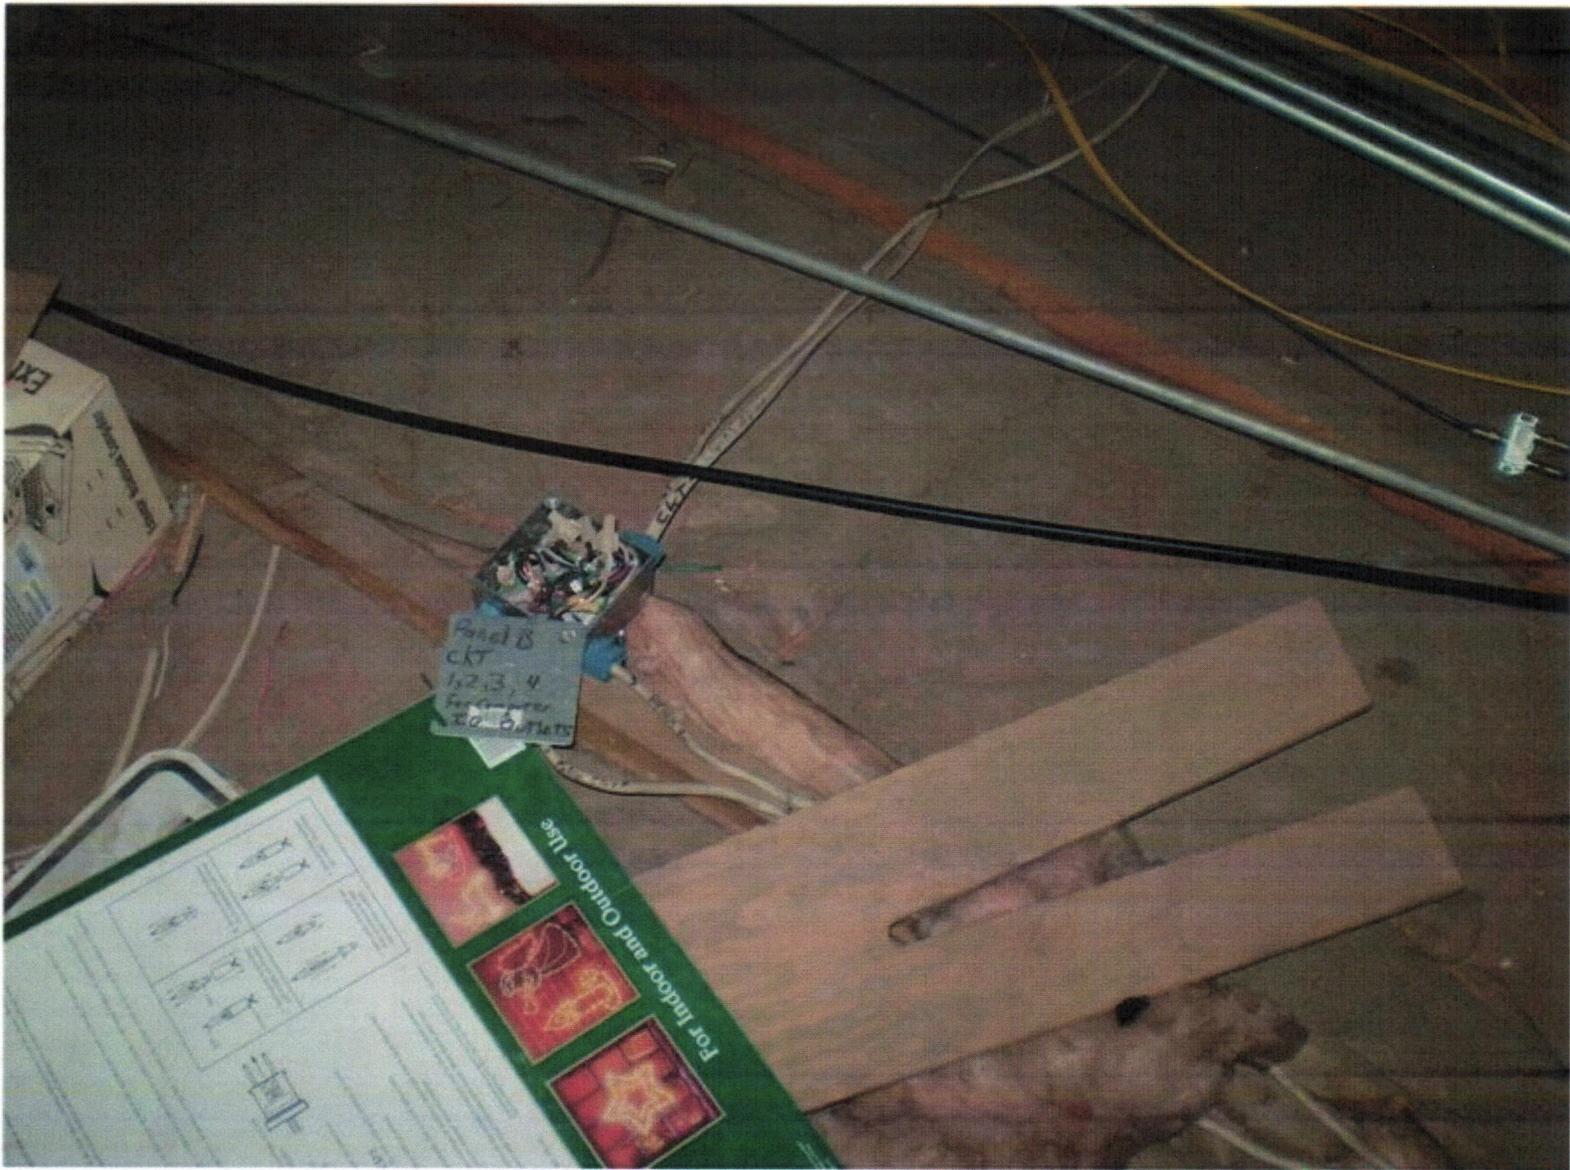
I saw some open electrical junction boxes in the attic. All junction boxes should have their covers in place to contain sparks should they occur.

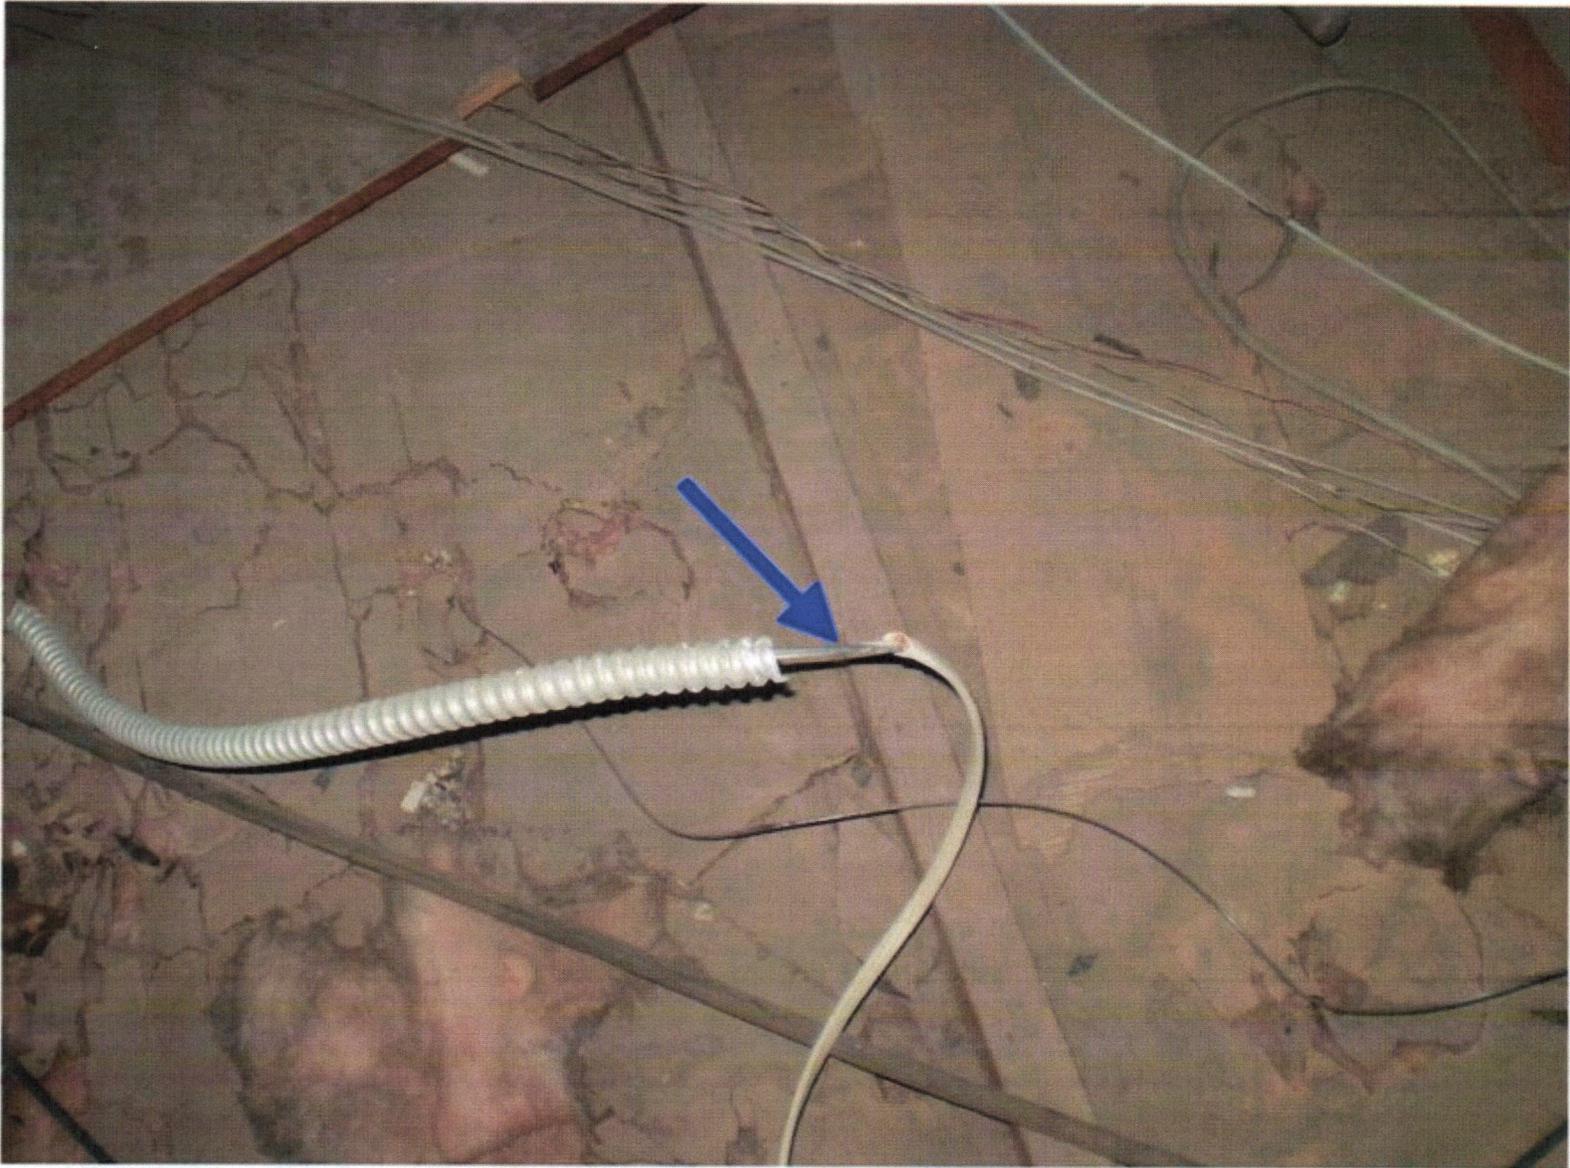
This flex conduit is not long enough to cover the wire where the sheathing has been stripped off. Aug 4, 2008 13:32

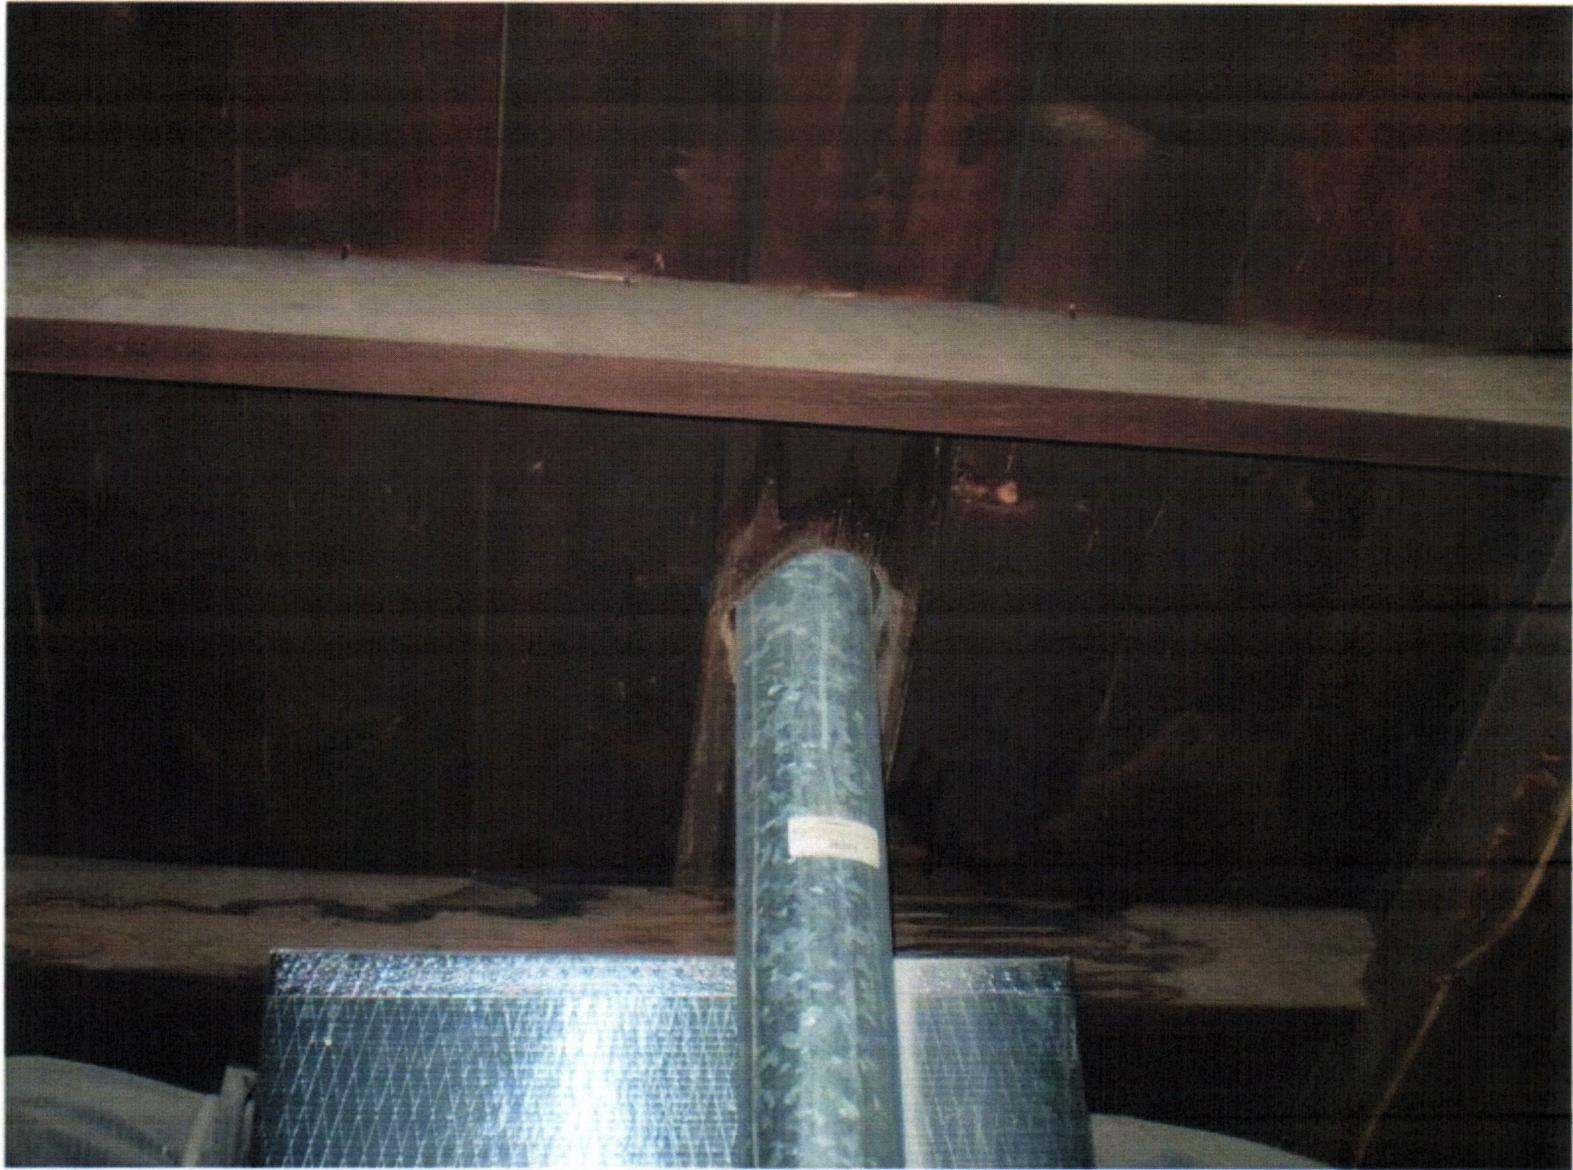
This is the vent (chimney) to the new furnace in the attic. Notice that the required one inch clearance was not provided between the vent and combustibles.

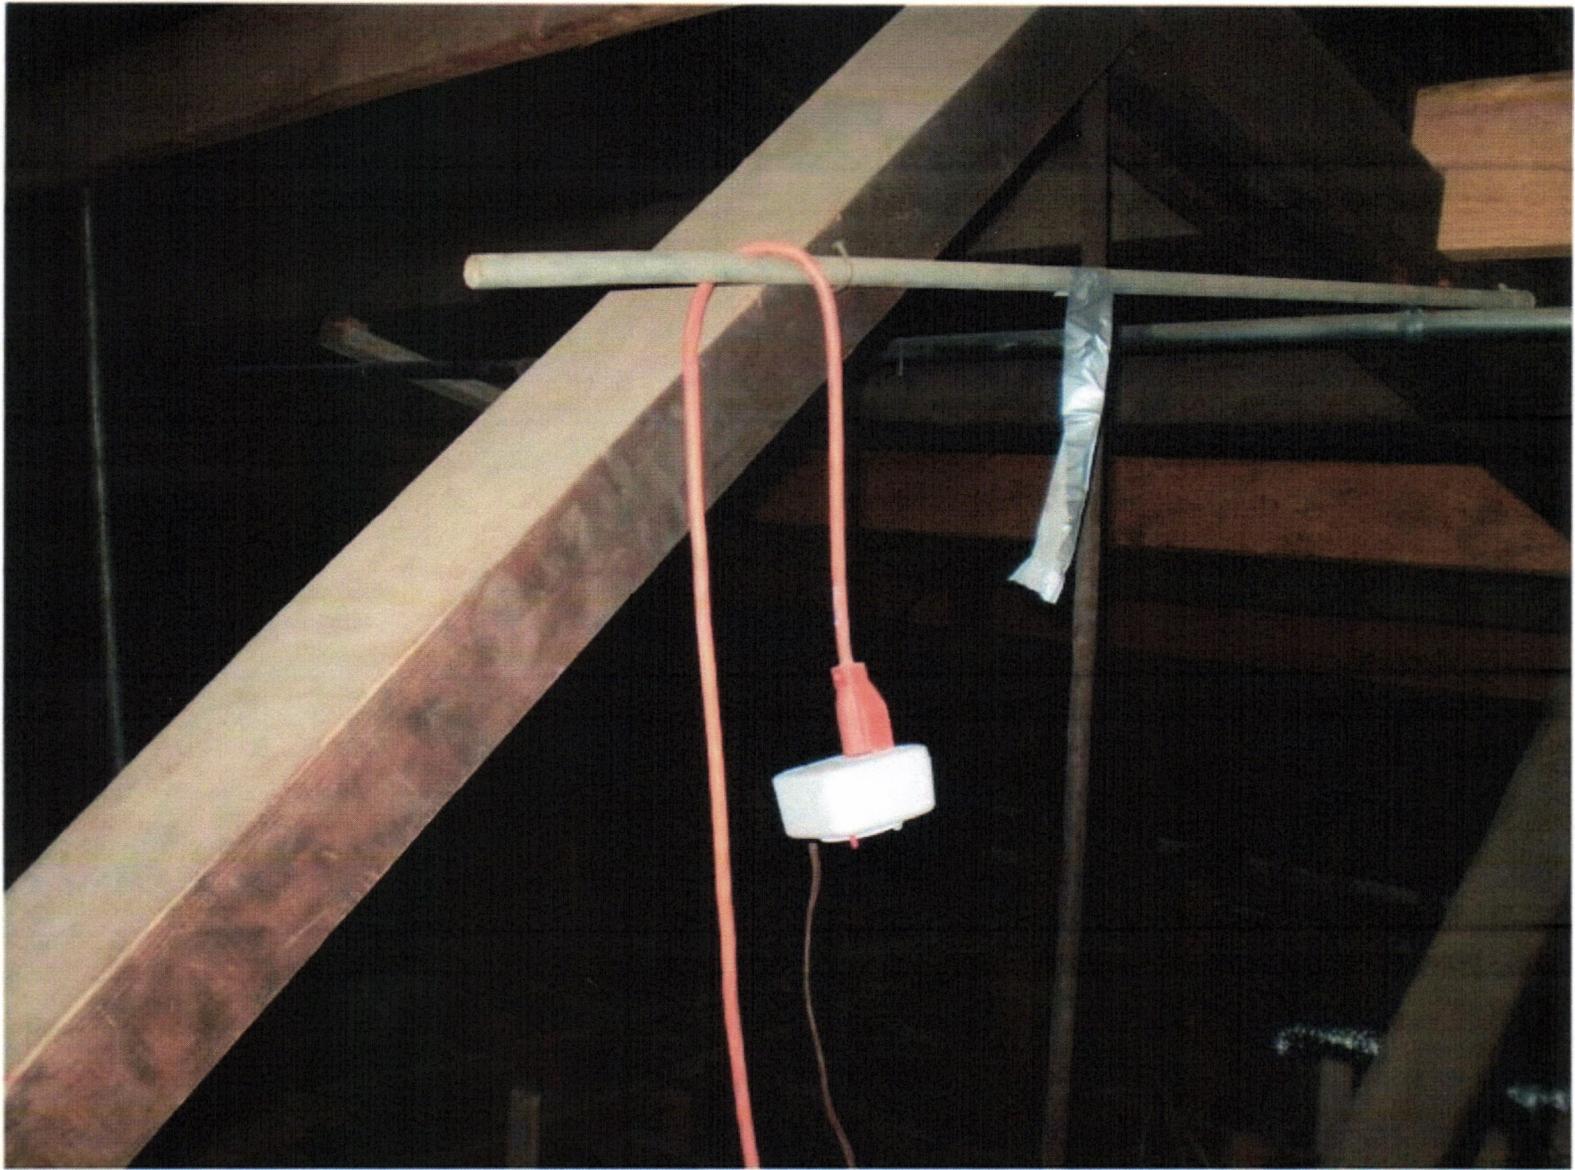
This extension cord is being used as permanent wiring which is not within the electrical code. Aug 4, 2008 13:35

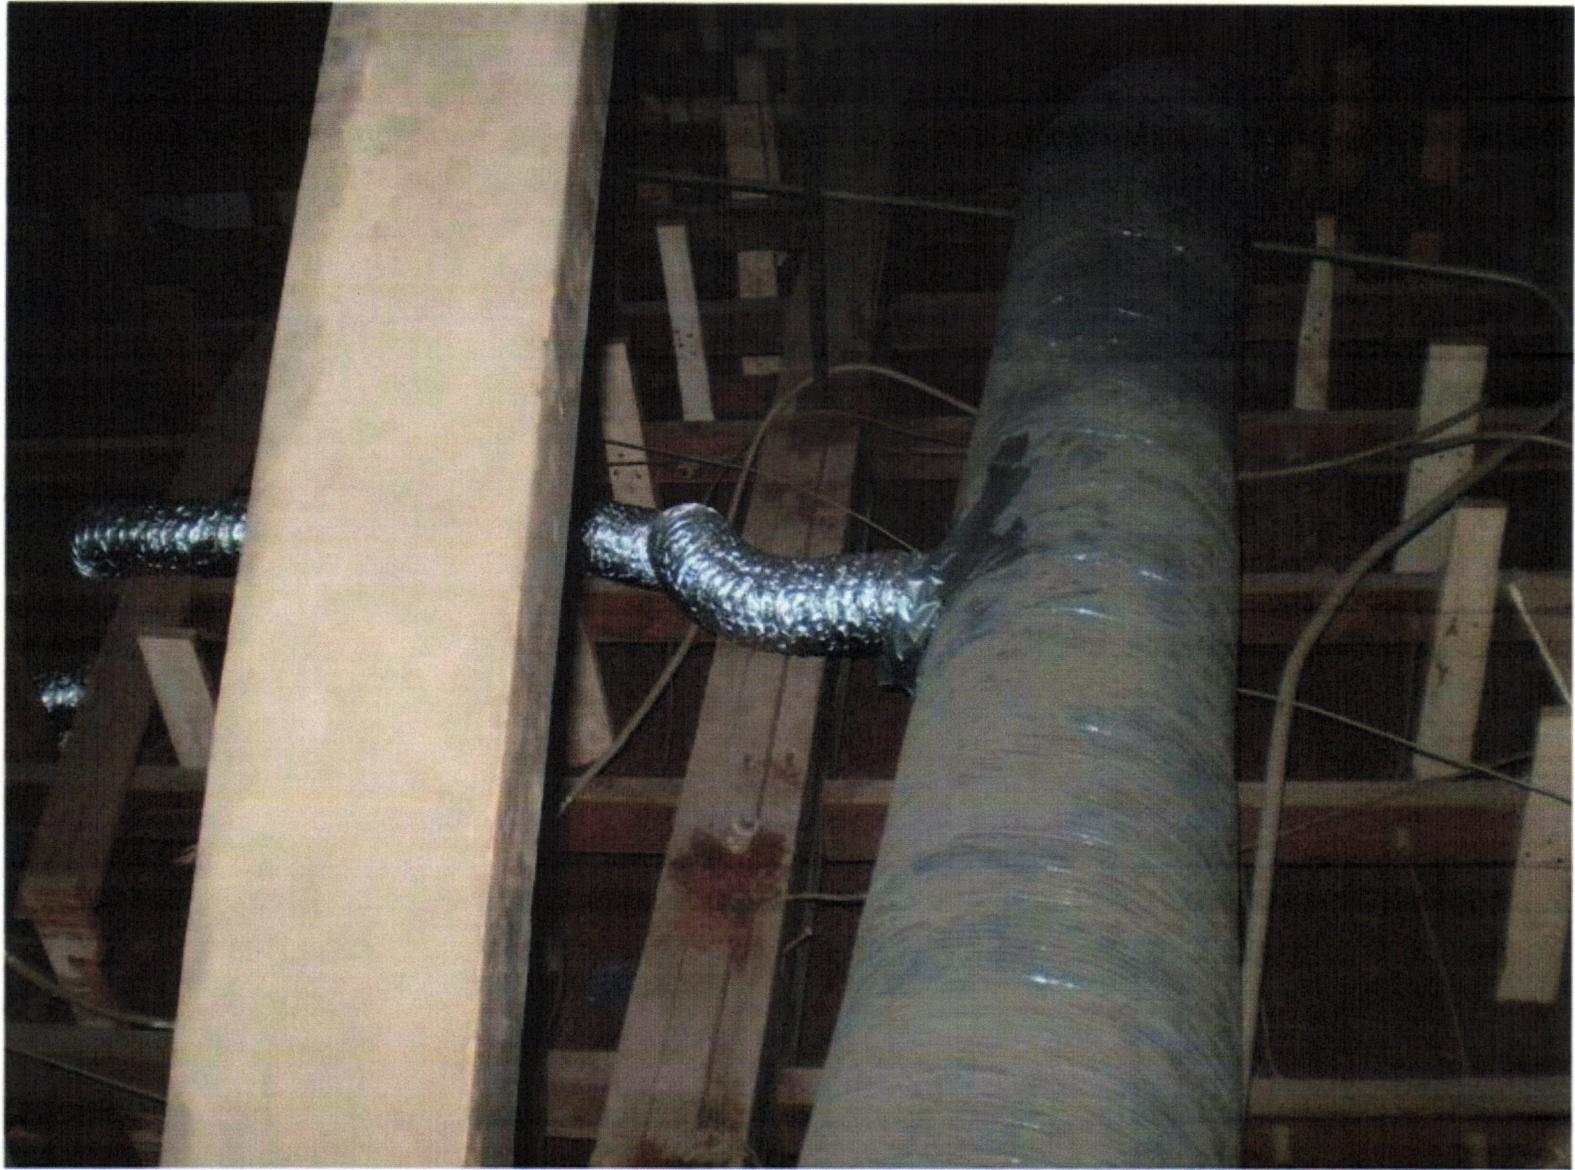
This heat supply duct has been taped with a dryer vent. It works but dryer vent is not insulated Aug 4, 2008 13:36

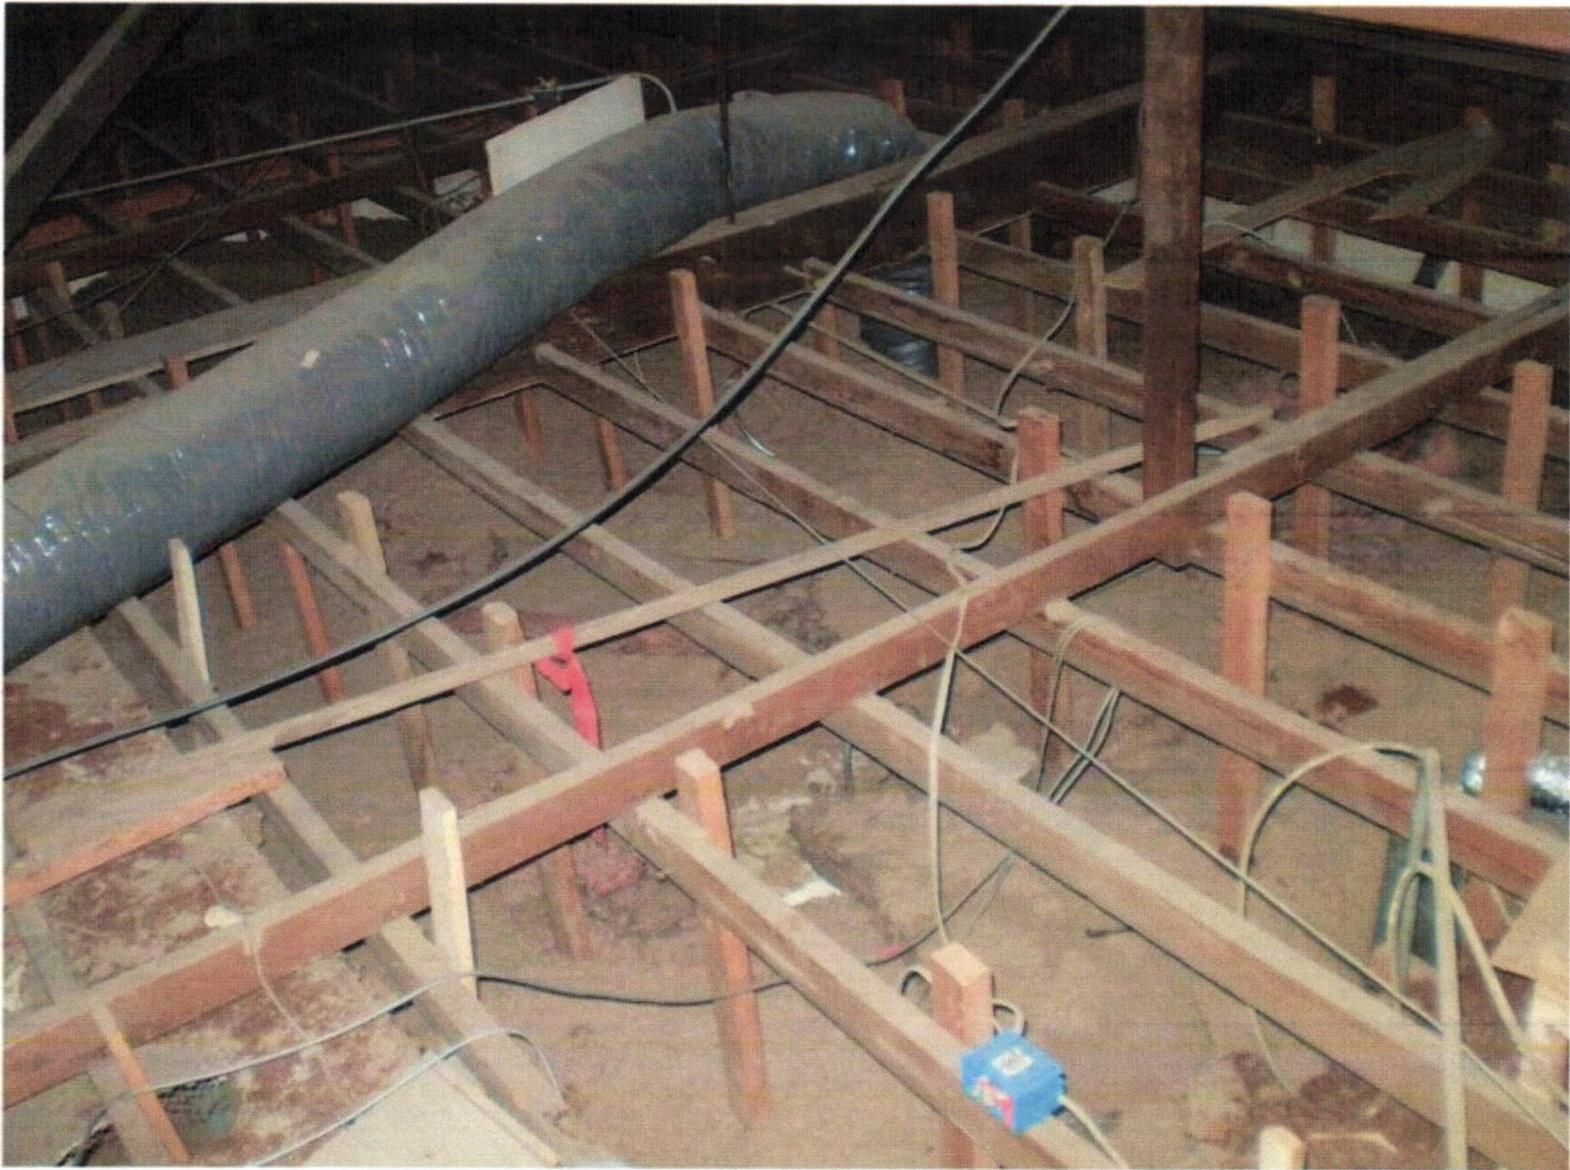
This is a view of a dropped ceiling as seen from the attic **Aug 4, 2008 13:36**
