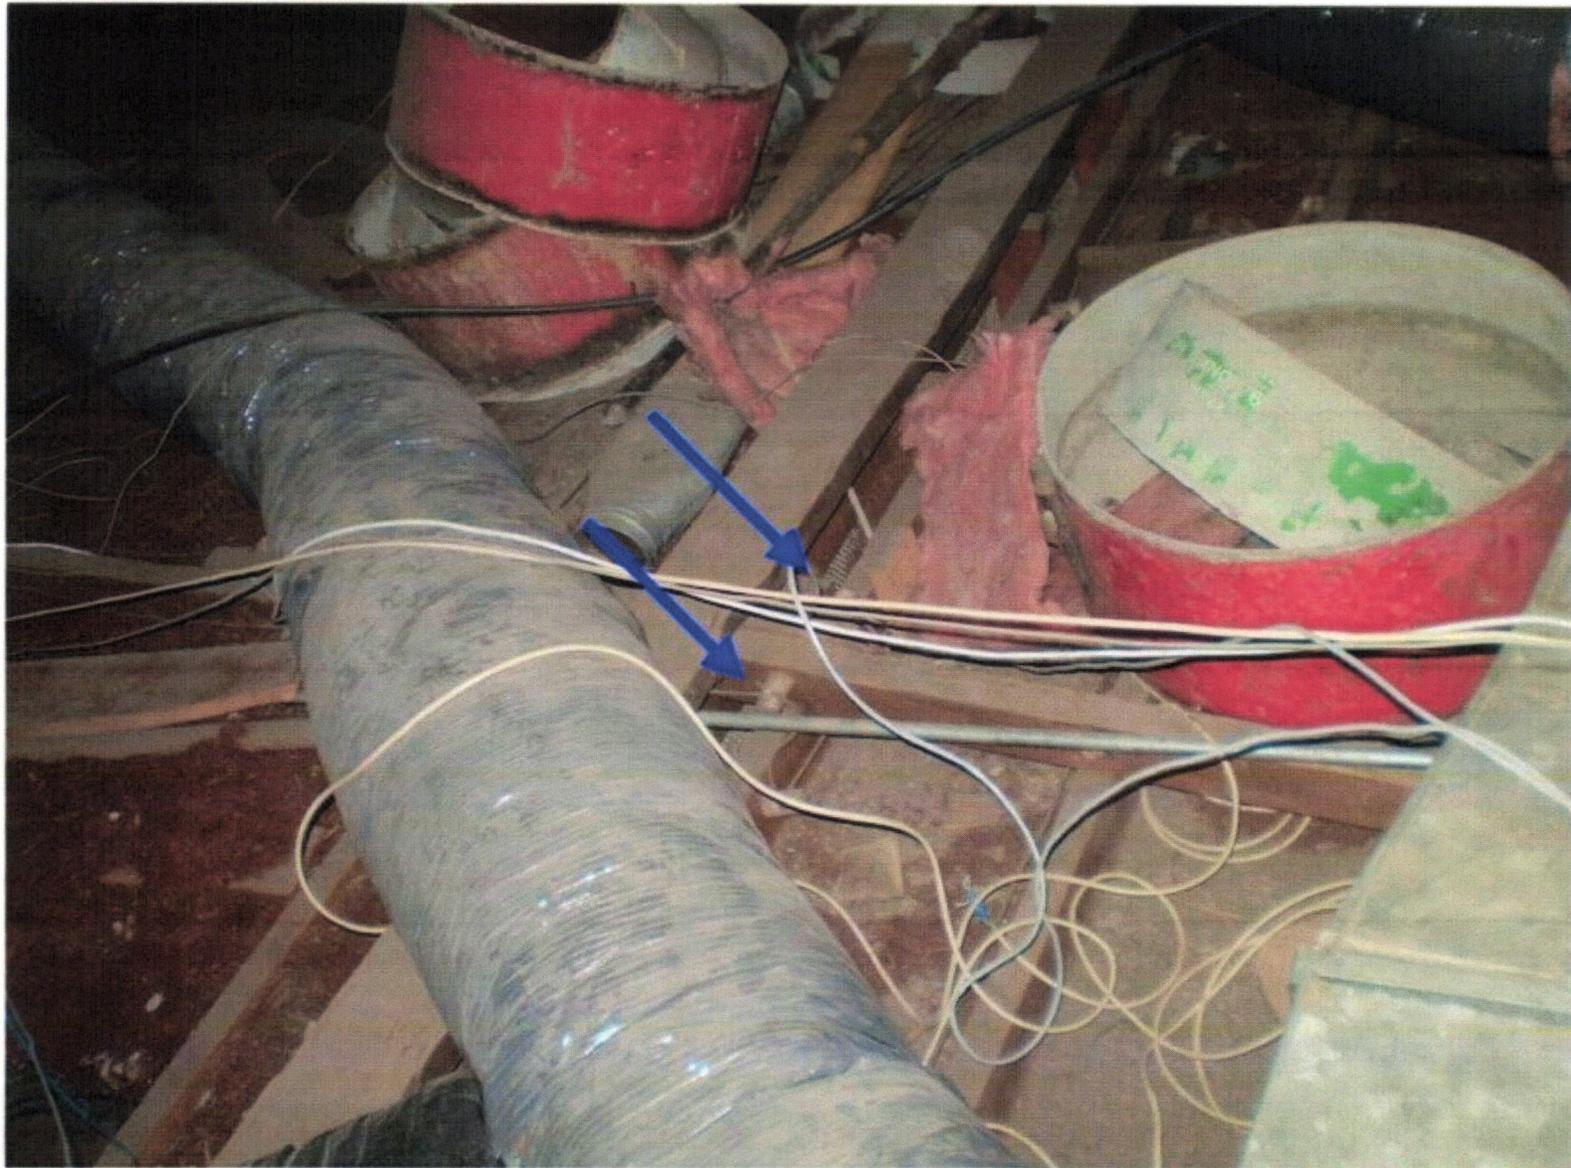
I saw old knob and tube wiring in the attic but did not determine if it is still in use. All abandon wiring should have been removed when upgrading the electrical system took place.

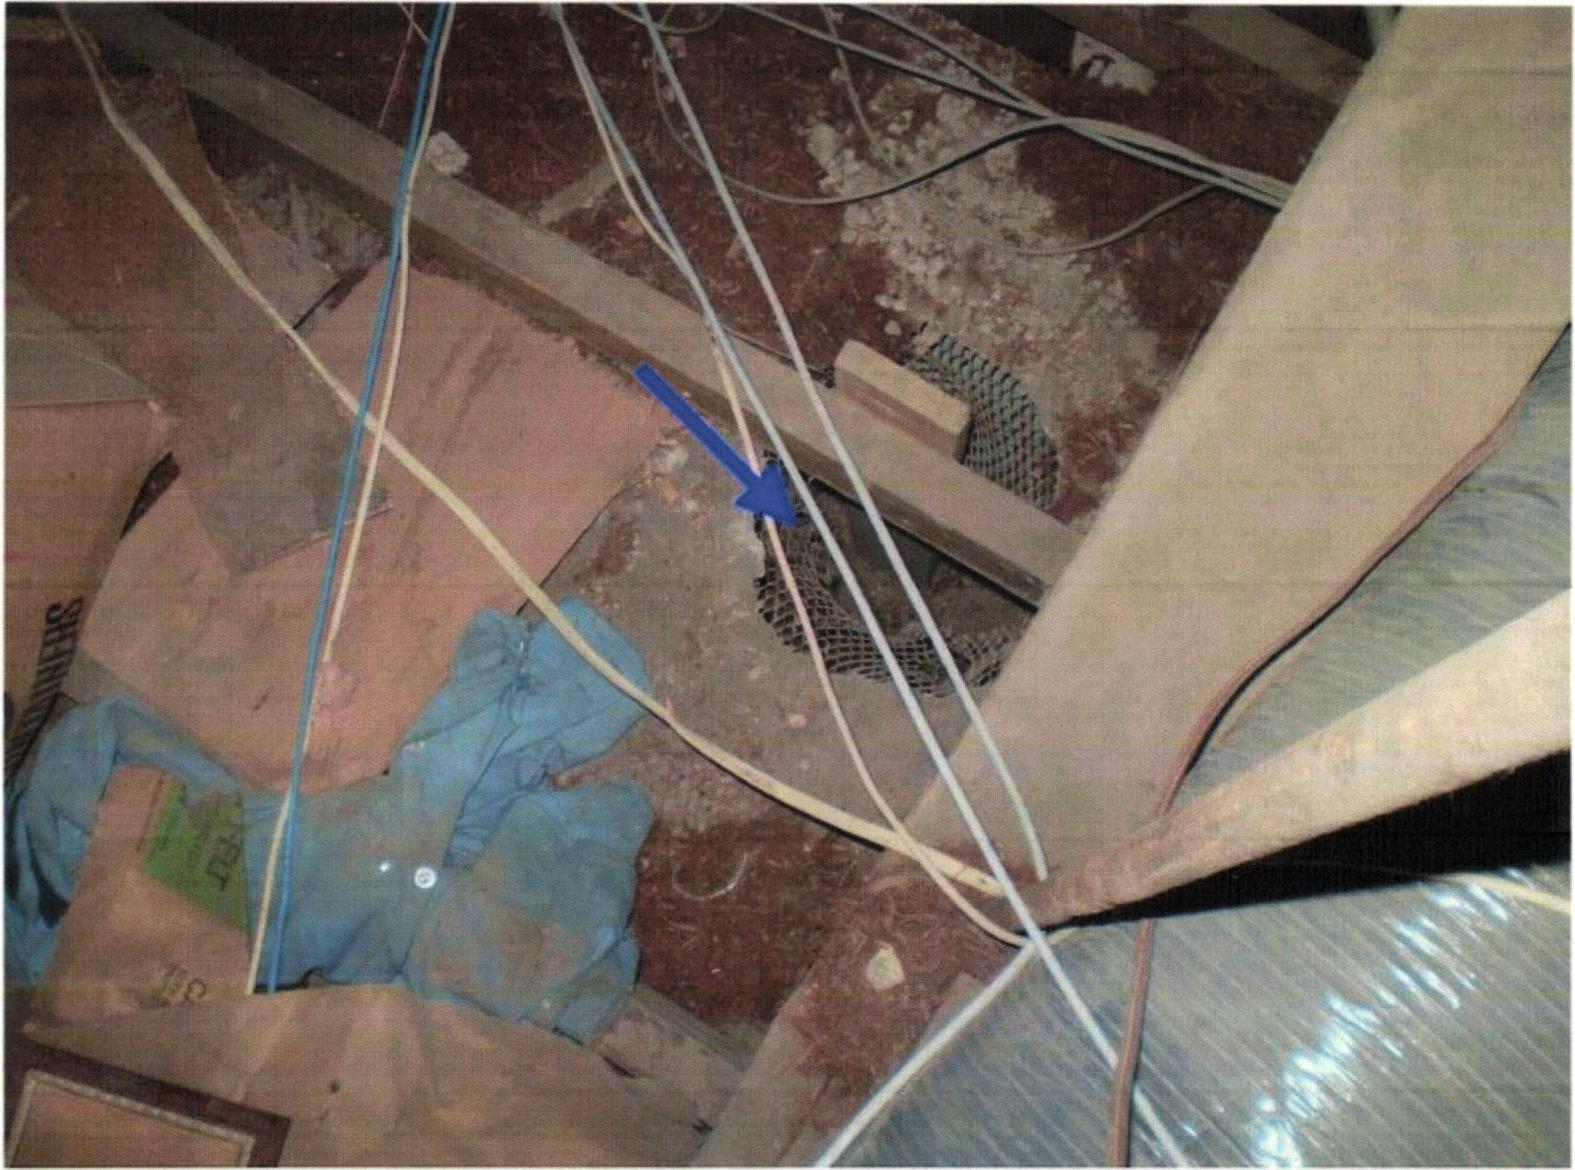
The arrow points to a hole in the original ceiling. The ceilings in use are dropped and there is insulation in those attic spaces. The concern is there are concealed attic spaces that make fighting fire very difficult and dangerous.

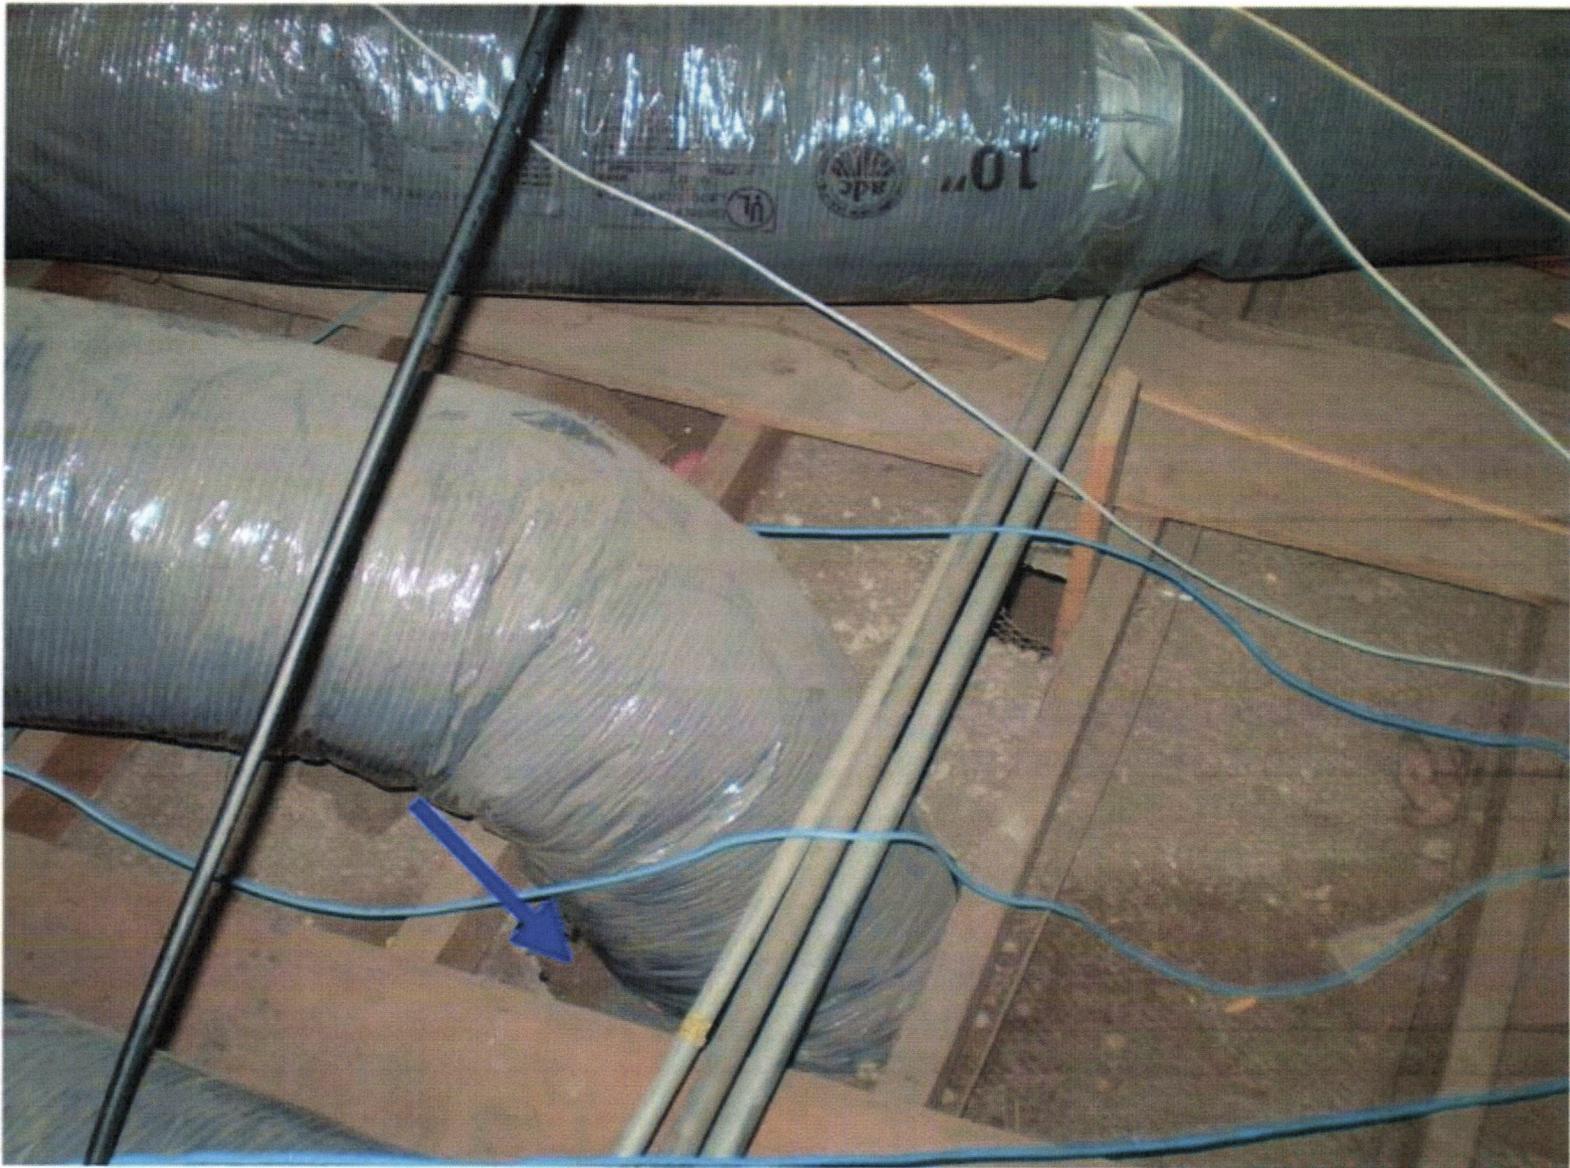
A better view into the concealed attic spaces.

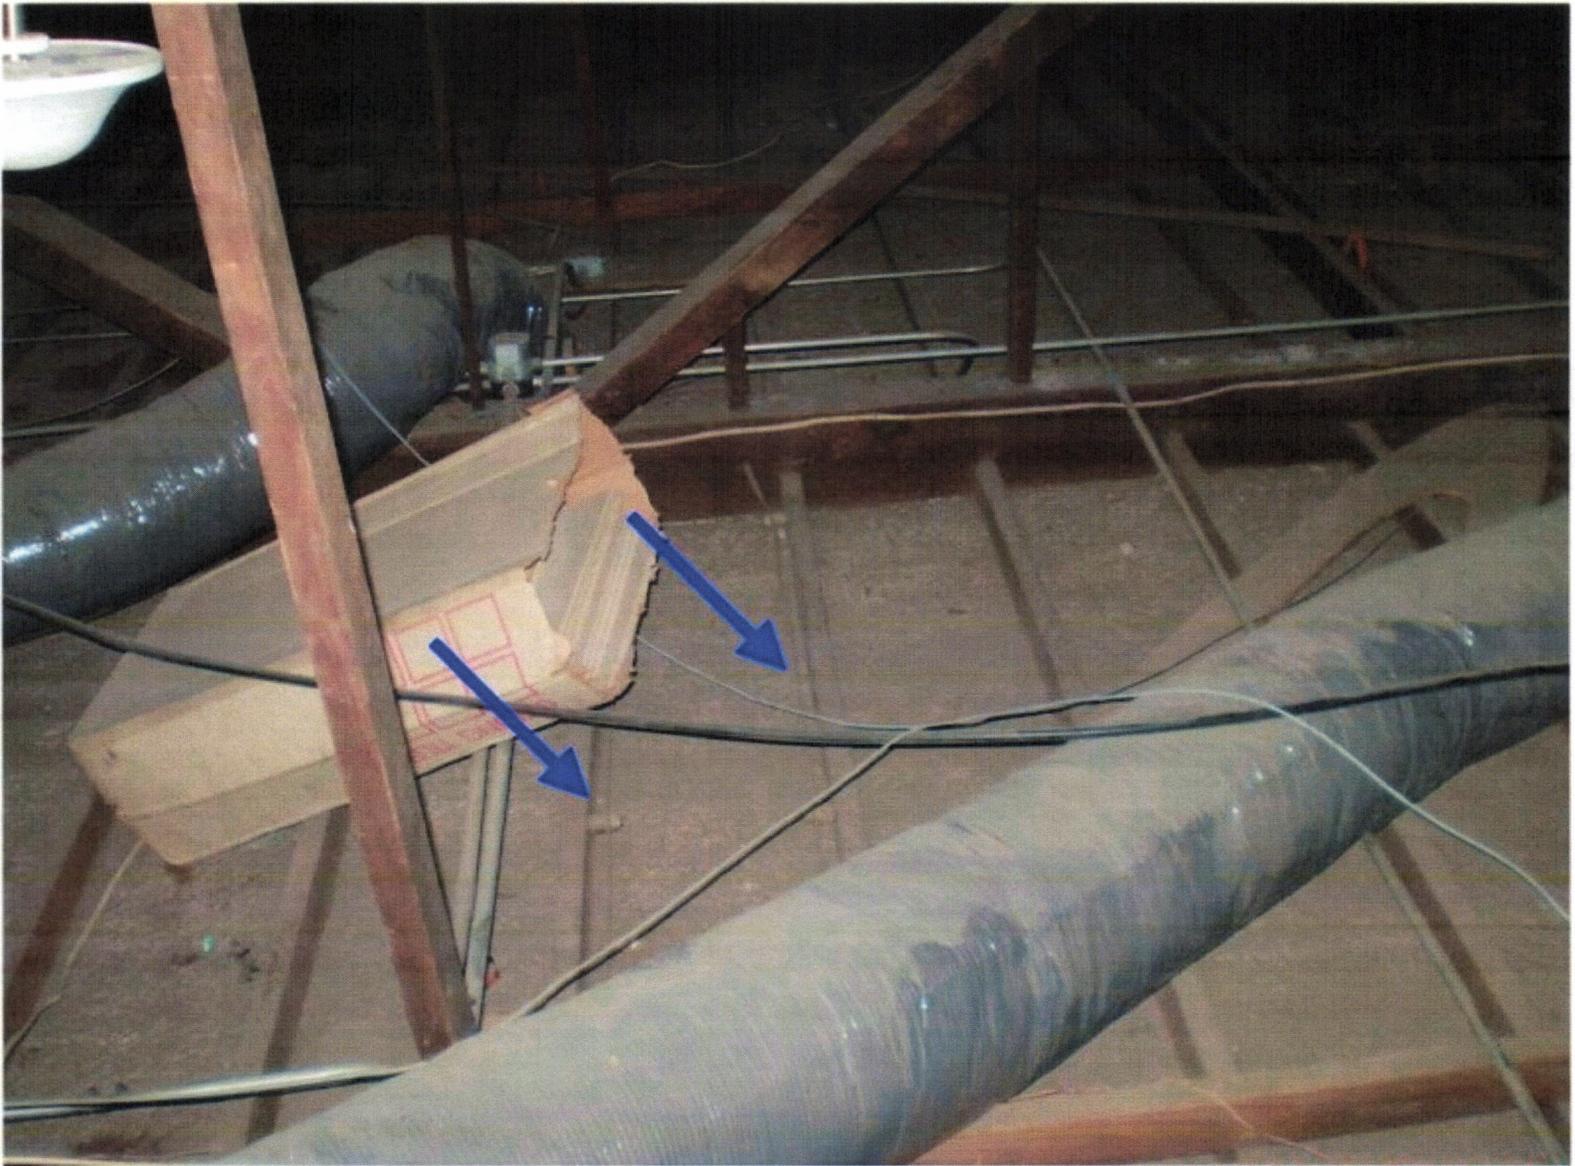
More knob and tube wiring. This wiring is about the 1930 decade

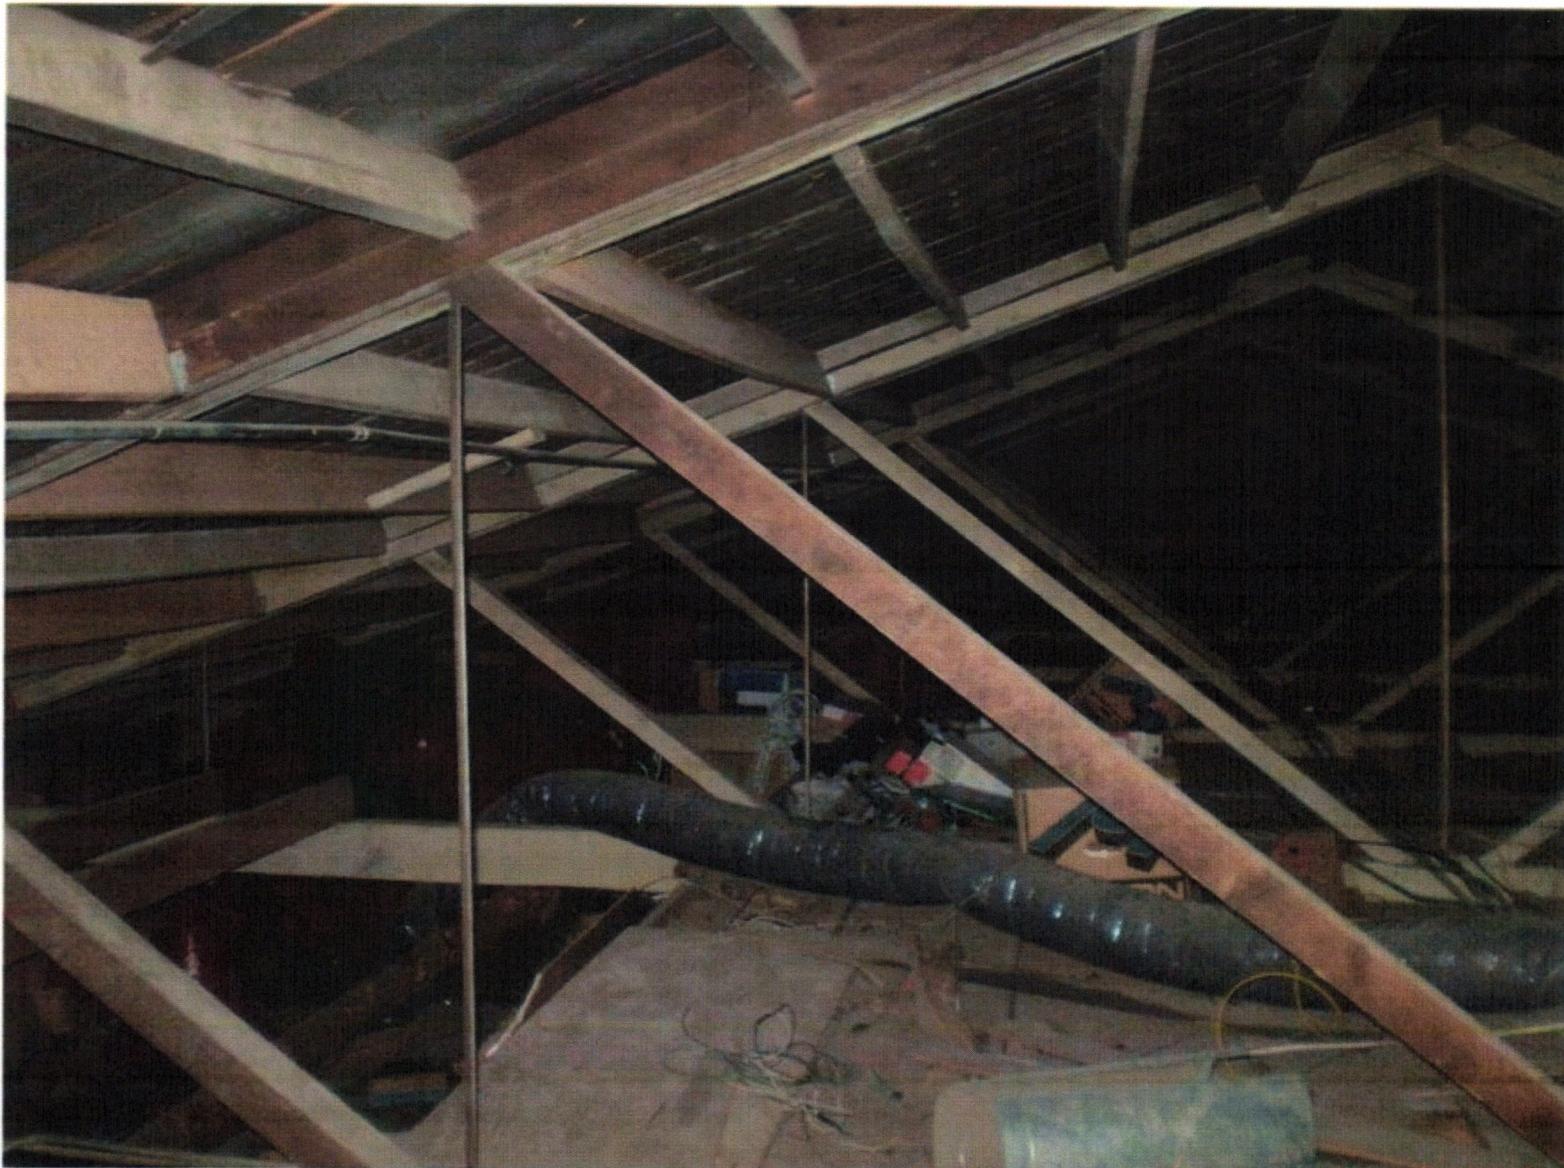
This a general view of the attic. Note the items stored. This is one of the faults with easily accessible attics. Extra loads are placed on the roof system and flammable items could get stored in an attic. (none seen). Note that the attic is poorly ventilated. (no visible light)
